LISTED BUILDING CONSENT COMPLIANCE SUBMISSION

PRE-COMMENCEMENT CONDITION DISCHARGE APPLICATION

TRURO HOUSE

CONDITION ASSESSMENT AND
CONSERVATION RECOMMENDATIONS
FOR THE FIREPLACES AND
MAJOR DECORATIVE FEATURES

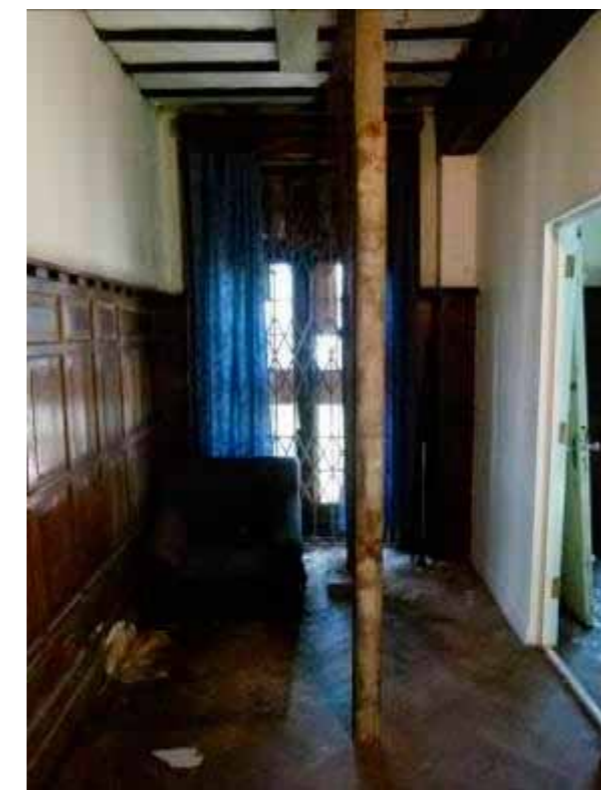
Signs of damage caused by damp were noted in various areas, including substantial rot to timber in the Entrance Hall.

Figure 4 Entrance Hall showing new partition wall and area of rot to timber on lower left side

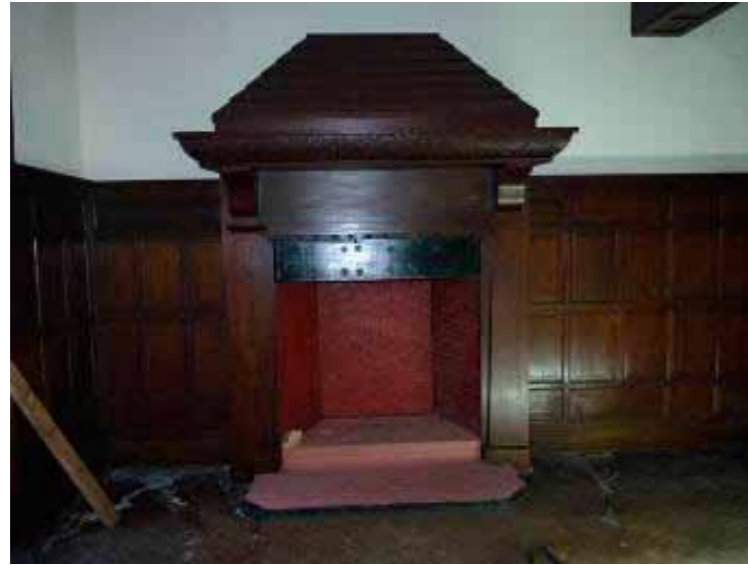
A large gothic style fireplace dominates the north elevation of the now enclosed Living Hall. The chimneypiece has a high-ridged hood with ornate timber carvings on the mantel. Red and pink over-paint has been applied to the fire back and hearth and the carved timber has a heavy varnish coating.

Figure 10 Living Hall, north elevation, fireplace

- Clean timber elements with white spirit applied over surfaces using lint-free cotton rags.
- Apply light coating of Microcrystalline wax over cleaned timber and buff to a soft sheen.
- Remove over-paint from fire back and hearth with proprietary paint stripper.
- Apply protections to all areas of fireplace and parquet flooring prior to stripping, taking care not to affect timber elements.
- Remove metal hood from mantel and replace internal hood to match original (Figure 9).
- All replacement fireplace fixtures and fittings should be matched to the original as closely as possible.

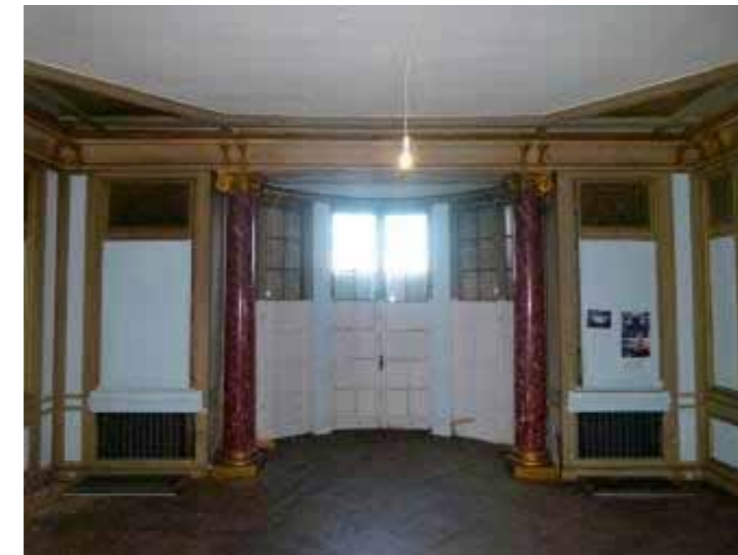
Two ionic scagliola columns with gilded capitals and bases flank a large bay window to the south elevation. This area of the room is showing signs of damage due to damp and water ingress. Flaking paint and plasterwork were noted particularly along the ceiling between the two columns. Small localised areas of faded colour were noted on the columns.

Figure 17 Drawing Room, south elevation, showing scagliola columns and bay window

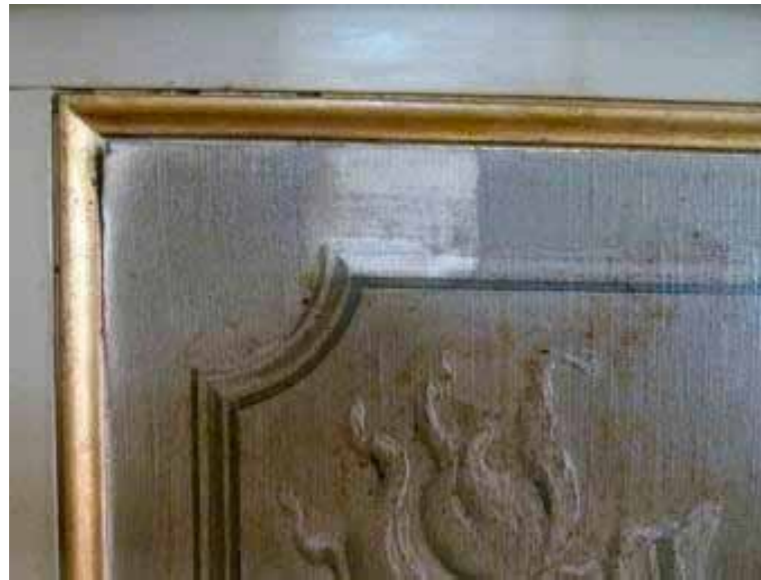
The paintings are covered with a layer of surface and more ingrained dirt and also appear to have been varnished. This varnish layer has discoloured over time and is further obscuring the detail and subtle colours of the grisaille.

Figure 22 Drawing Room, cleaning trial to wall panel above cupboards

- We recommend that all conservation cleaning be carried out by trained conservators.

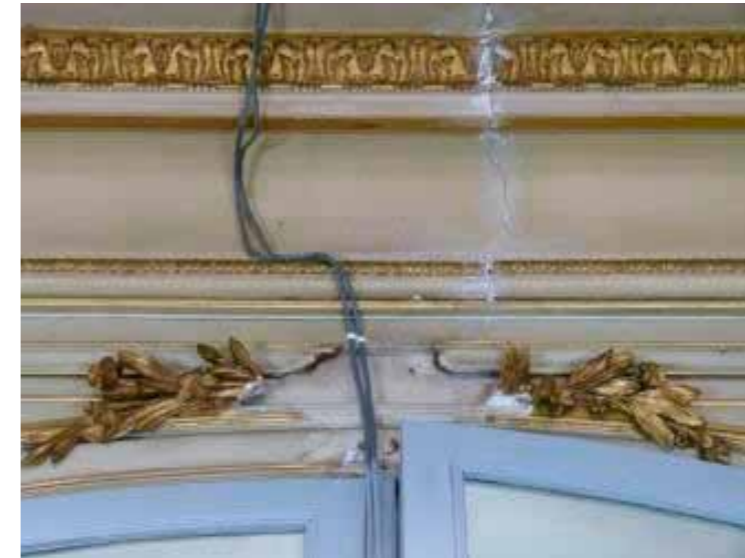
Most of the walls and ceiling have been re-painted with modern emulsion. The gilded beading framing the wall panels have also been over-painted. Some decorative plaster elements have been damaged or lost such as over the door (Figure 25). The gilded surfaces are covered with a layer of surface and more ingrained dirt.

Figure 25 Drawing Room, detail of damage and loss to moulding over the doors

- Take moulds from existing plaster ornament to re-cast and repair missing and lost plaster sections.
- Following repairs and re-painting to the room, we recommend the panel beading and plaster repairs are re-gilded and toned to match the original.

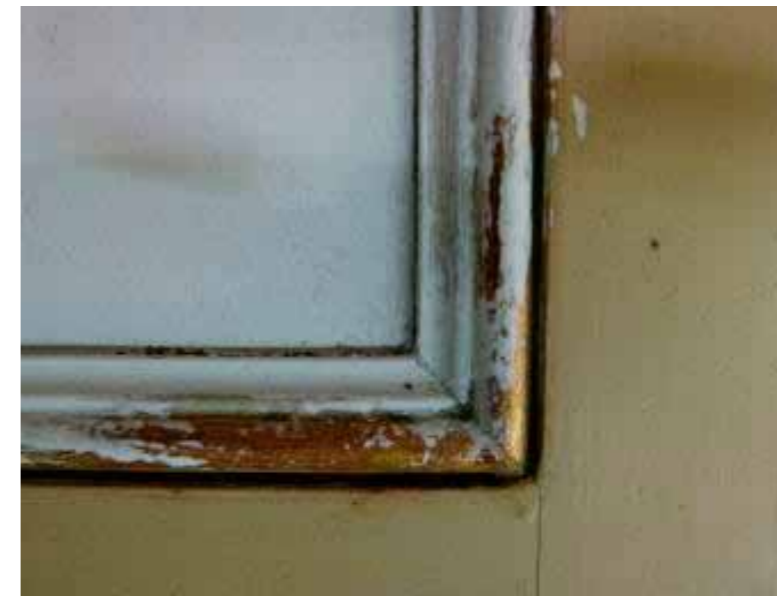
Figure 26 Drawing Room, attempts to remove over-paint from gilded beading

- Remove surface dirt and debris with soft brushes and vacuuming.
- Clean all exposed original gilding with a weak 2-3% solution of tri-ammonium citrate and 1-2% solution of ammonium hydroxide carefully applied with cotton wool swabs (Figure 27). We recommend carrying out further trials before cleaning to establish methodology and materials.

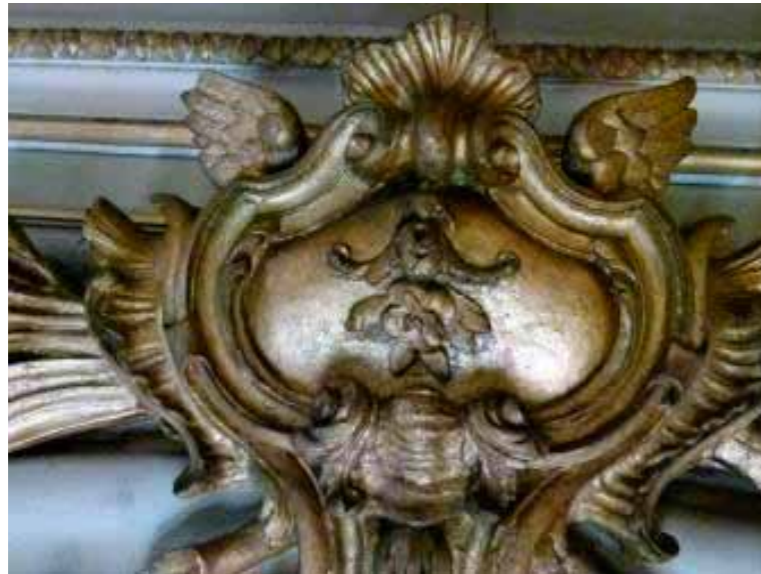
Figure 27 Drawing Room, showing surface cleaning to right side of moulding

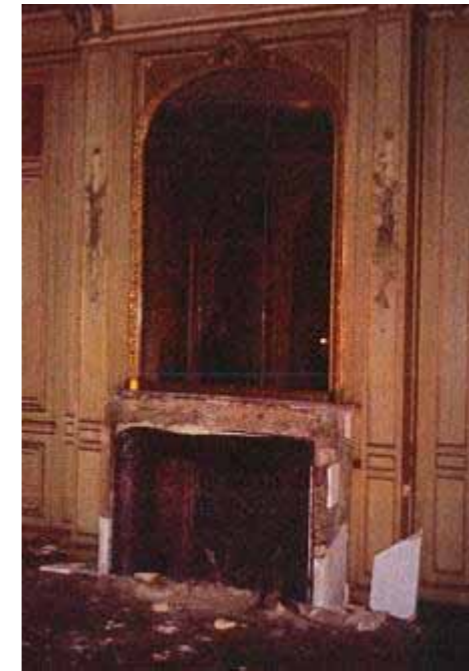
Figure 29 Drawing Room, fireplace surround missing but remnants of original mantel and mirror remain

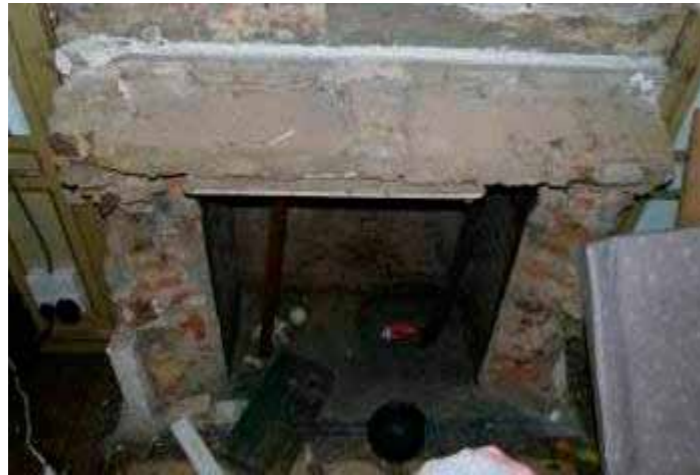
Figure 32 Drawing Room, missing fireplace, note marble hearth still present

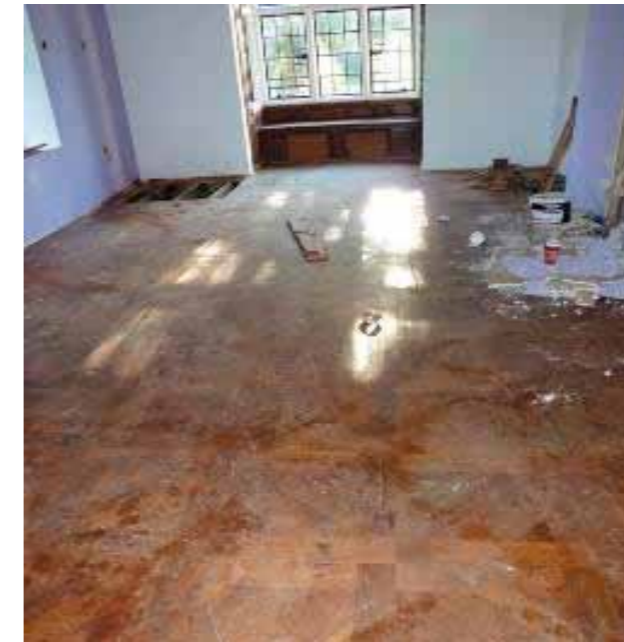
Figure 34 Dining Room, parquet flooring showing signs of wear and tear

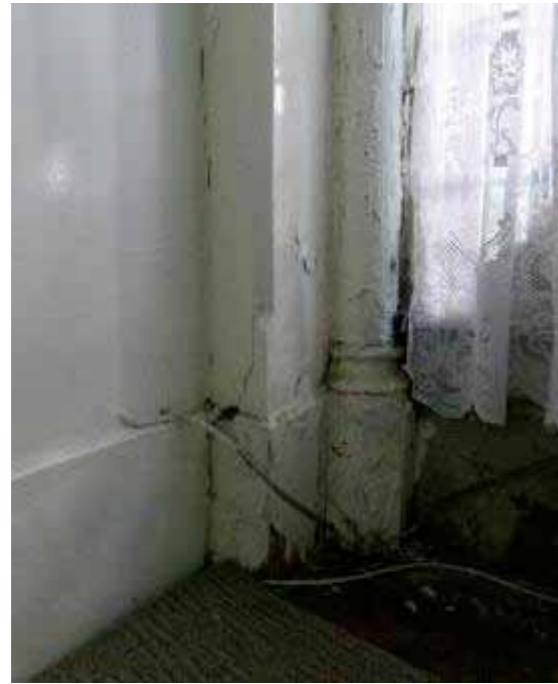
The columns either side of the window are showing problems associated with the ingress of water. Cracks and blistering to the paintwork were noted along with mould. The flooring throughout is showing signs of general wear and tear and would benefit from localised repairs, cleaning and re-finishing.

Figure 59 East end lobby, showing damage caused by damp conditions

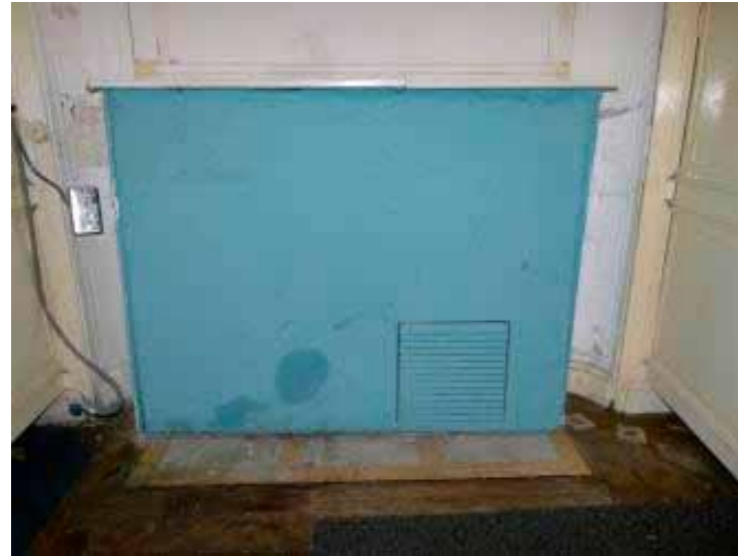
Figure 69 North East Bedroom, detail of cover fireplace opening (fireplace missing)

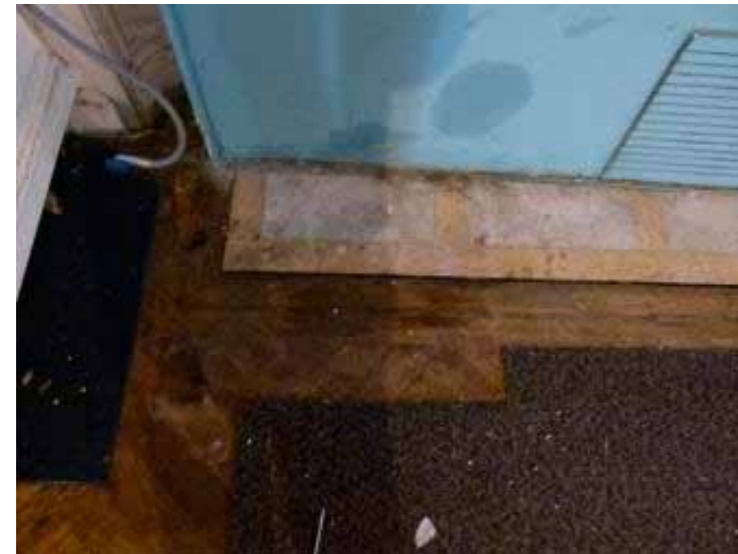
Figure 70 North East Bedroom, detail of marble hearth still remaining and damage to floor finish

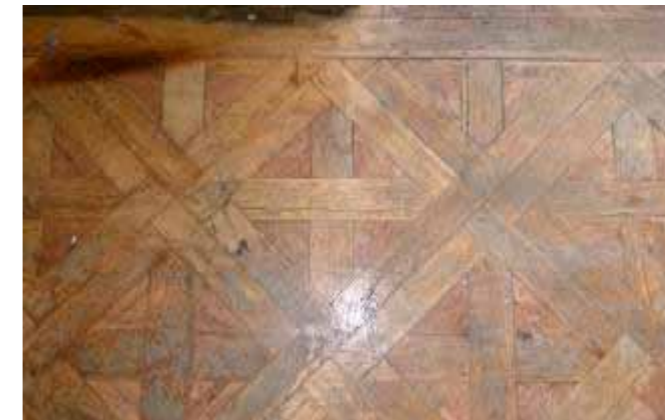
Figure 77 Normandy Bedroom, damage to floor finish caused by wear and tear

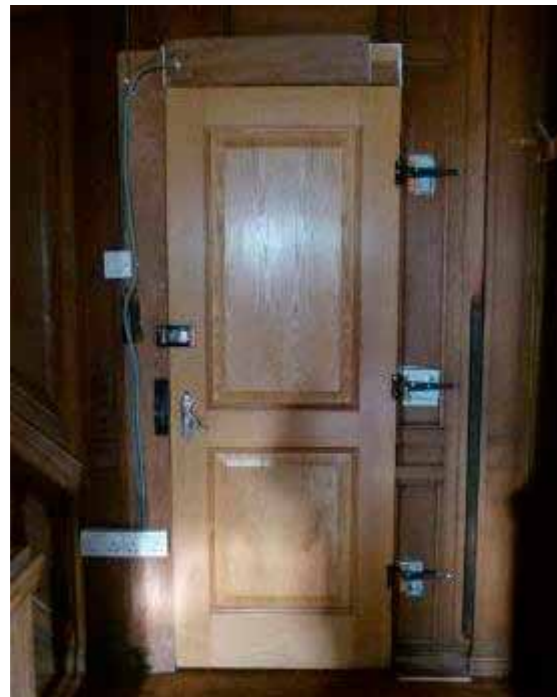
Figure 75 Normandy Bedroom, alteration to panelling to accommodate modern door

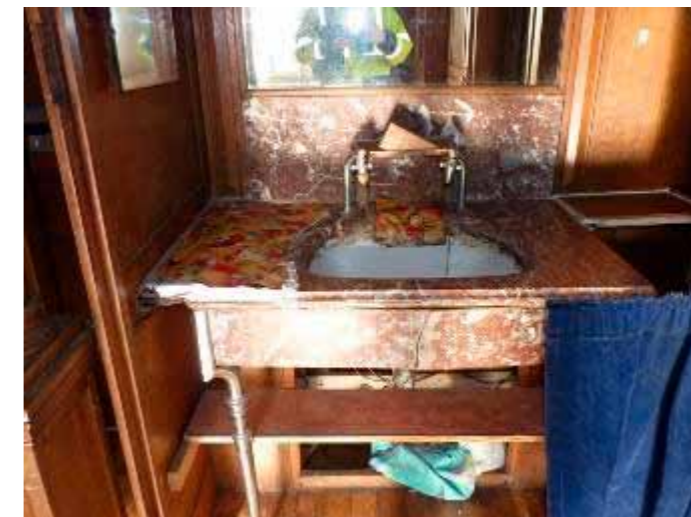
Figure 81 Normandy Bedroom, detail of damage to marble wash area

- Remove all debris and surface dirt with brushes and vacuuming.
- Clean marble with V&A mix.
- Stubborn more ingrained dirt can be reduced significantly by using Prelim polishing cream gently applied over the soiled areas with cotton wool swabs and rinsed with white spirit.
- Replacement marble should be matched as closely to the original. Repairs and fills should be pigmented or colour-matched to adjacent surfaces.
- Further consideration should be given on whether to repair or replace the sink. Any replacement should be sourced to match the original.

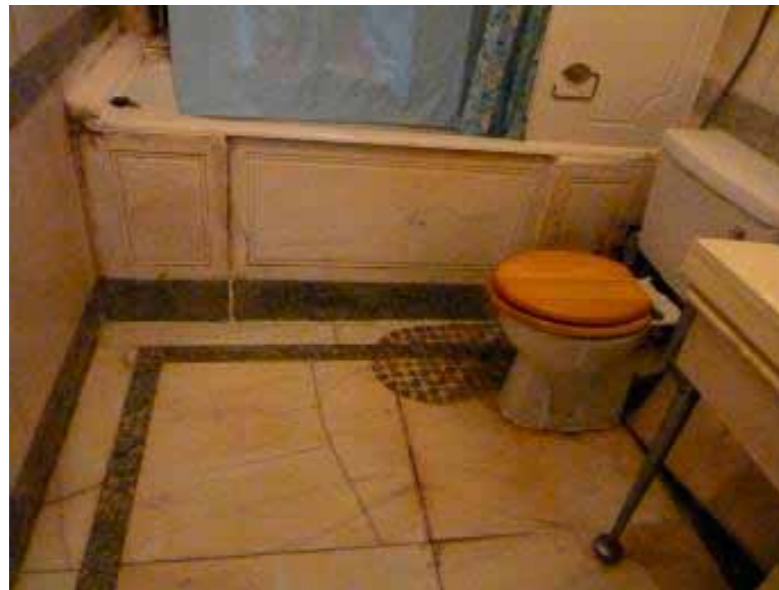
Although according to records the Bathroom is most probably a much later addition to the property it is very unusual in a house of this kind and represents a high level of craftsmanship despite its sorry state. The walls and floor are entirely lined with marble. Extensive cracking has occurred and much of the marble is stained and heavily soiled.

Figure 90 Bathroom, marble floor and bath surround showing cracks and staining

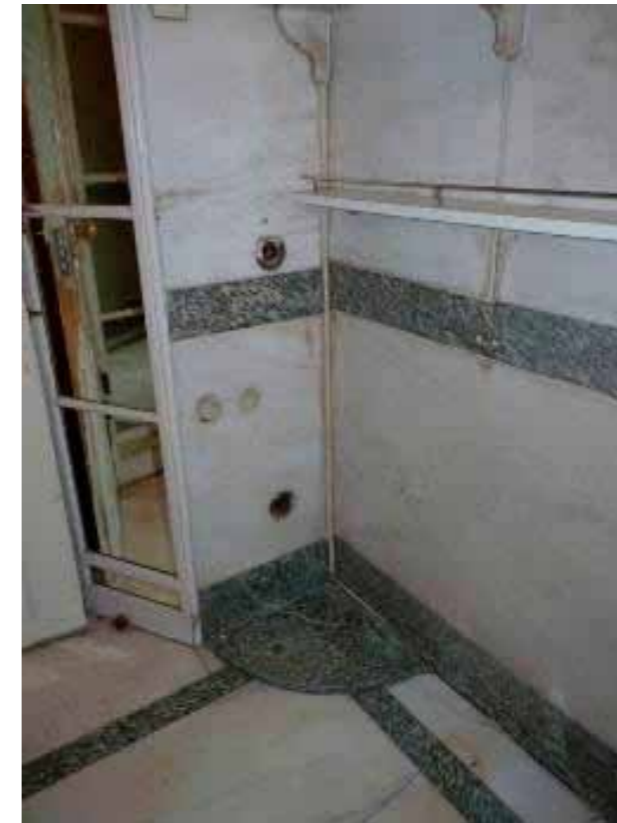
Figure 92 Bathroom, view of south east corner showing cracks and staining to marble

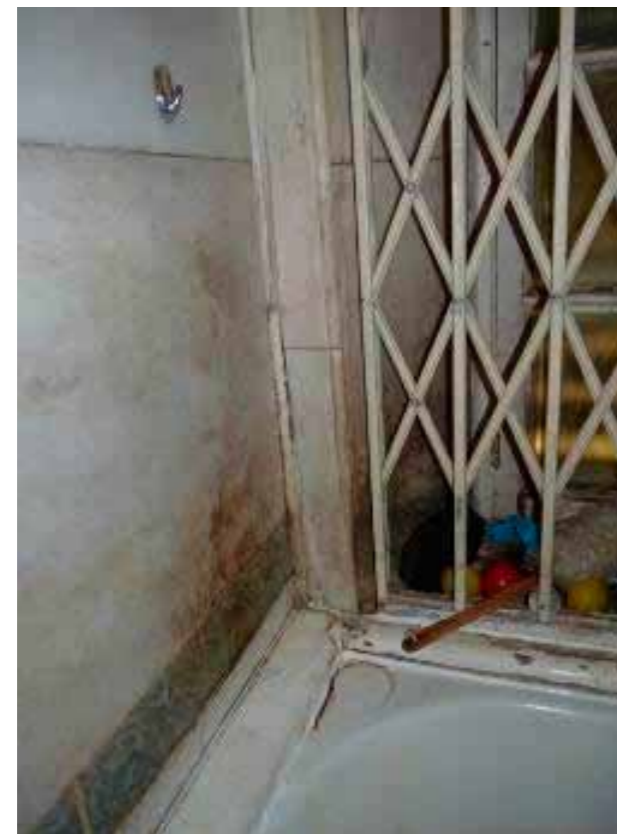
Figure 95 Bathroom, dirt and deep staining to marble in south west corner above bath near window

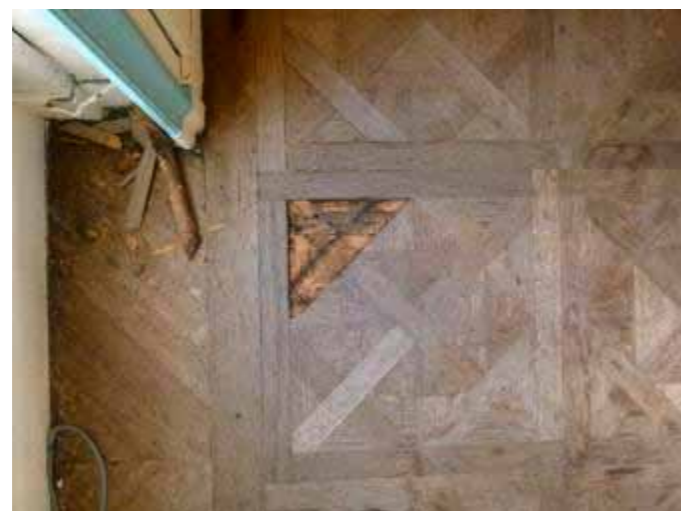
Figure 105 South West Bedroom, showing damage to parquet flooring

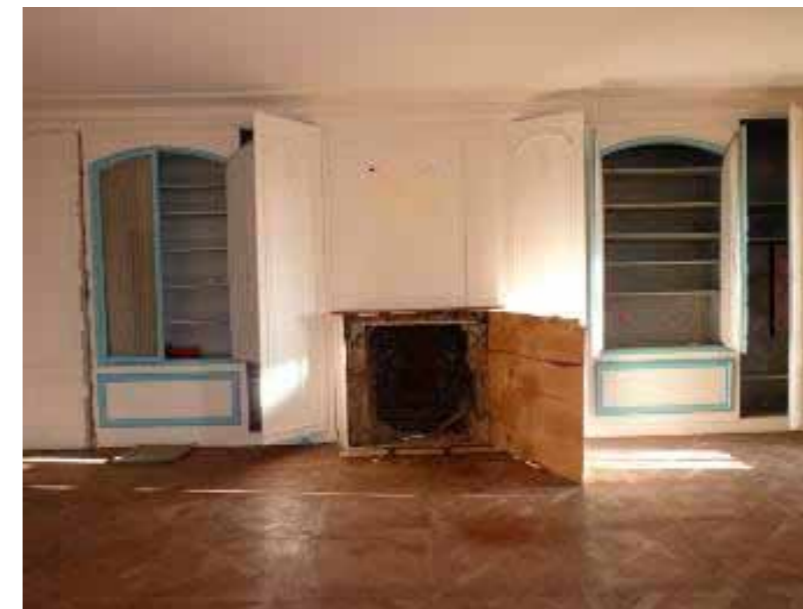
Figure 107 South West Bedroom, east elevation, showing hidden behind panelling and missing fire surround

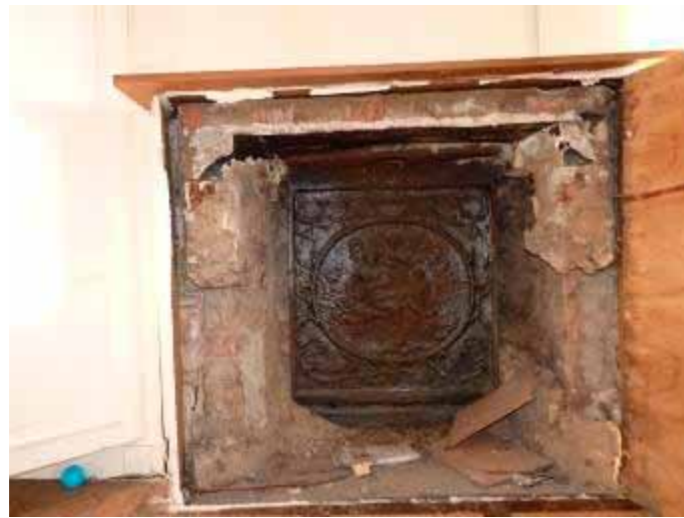
Figure 108 South West Bedroom, detail of missing fireplace, original fireback remains
