Palmers Green to Winchmore Hill, London Ecological Constraints Report

Network Rail

February 2015

Report Ref: 5398

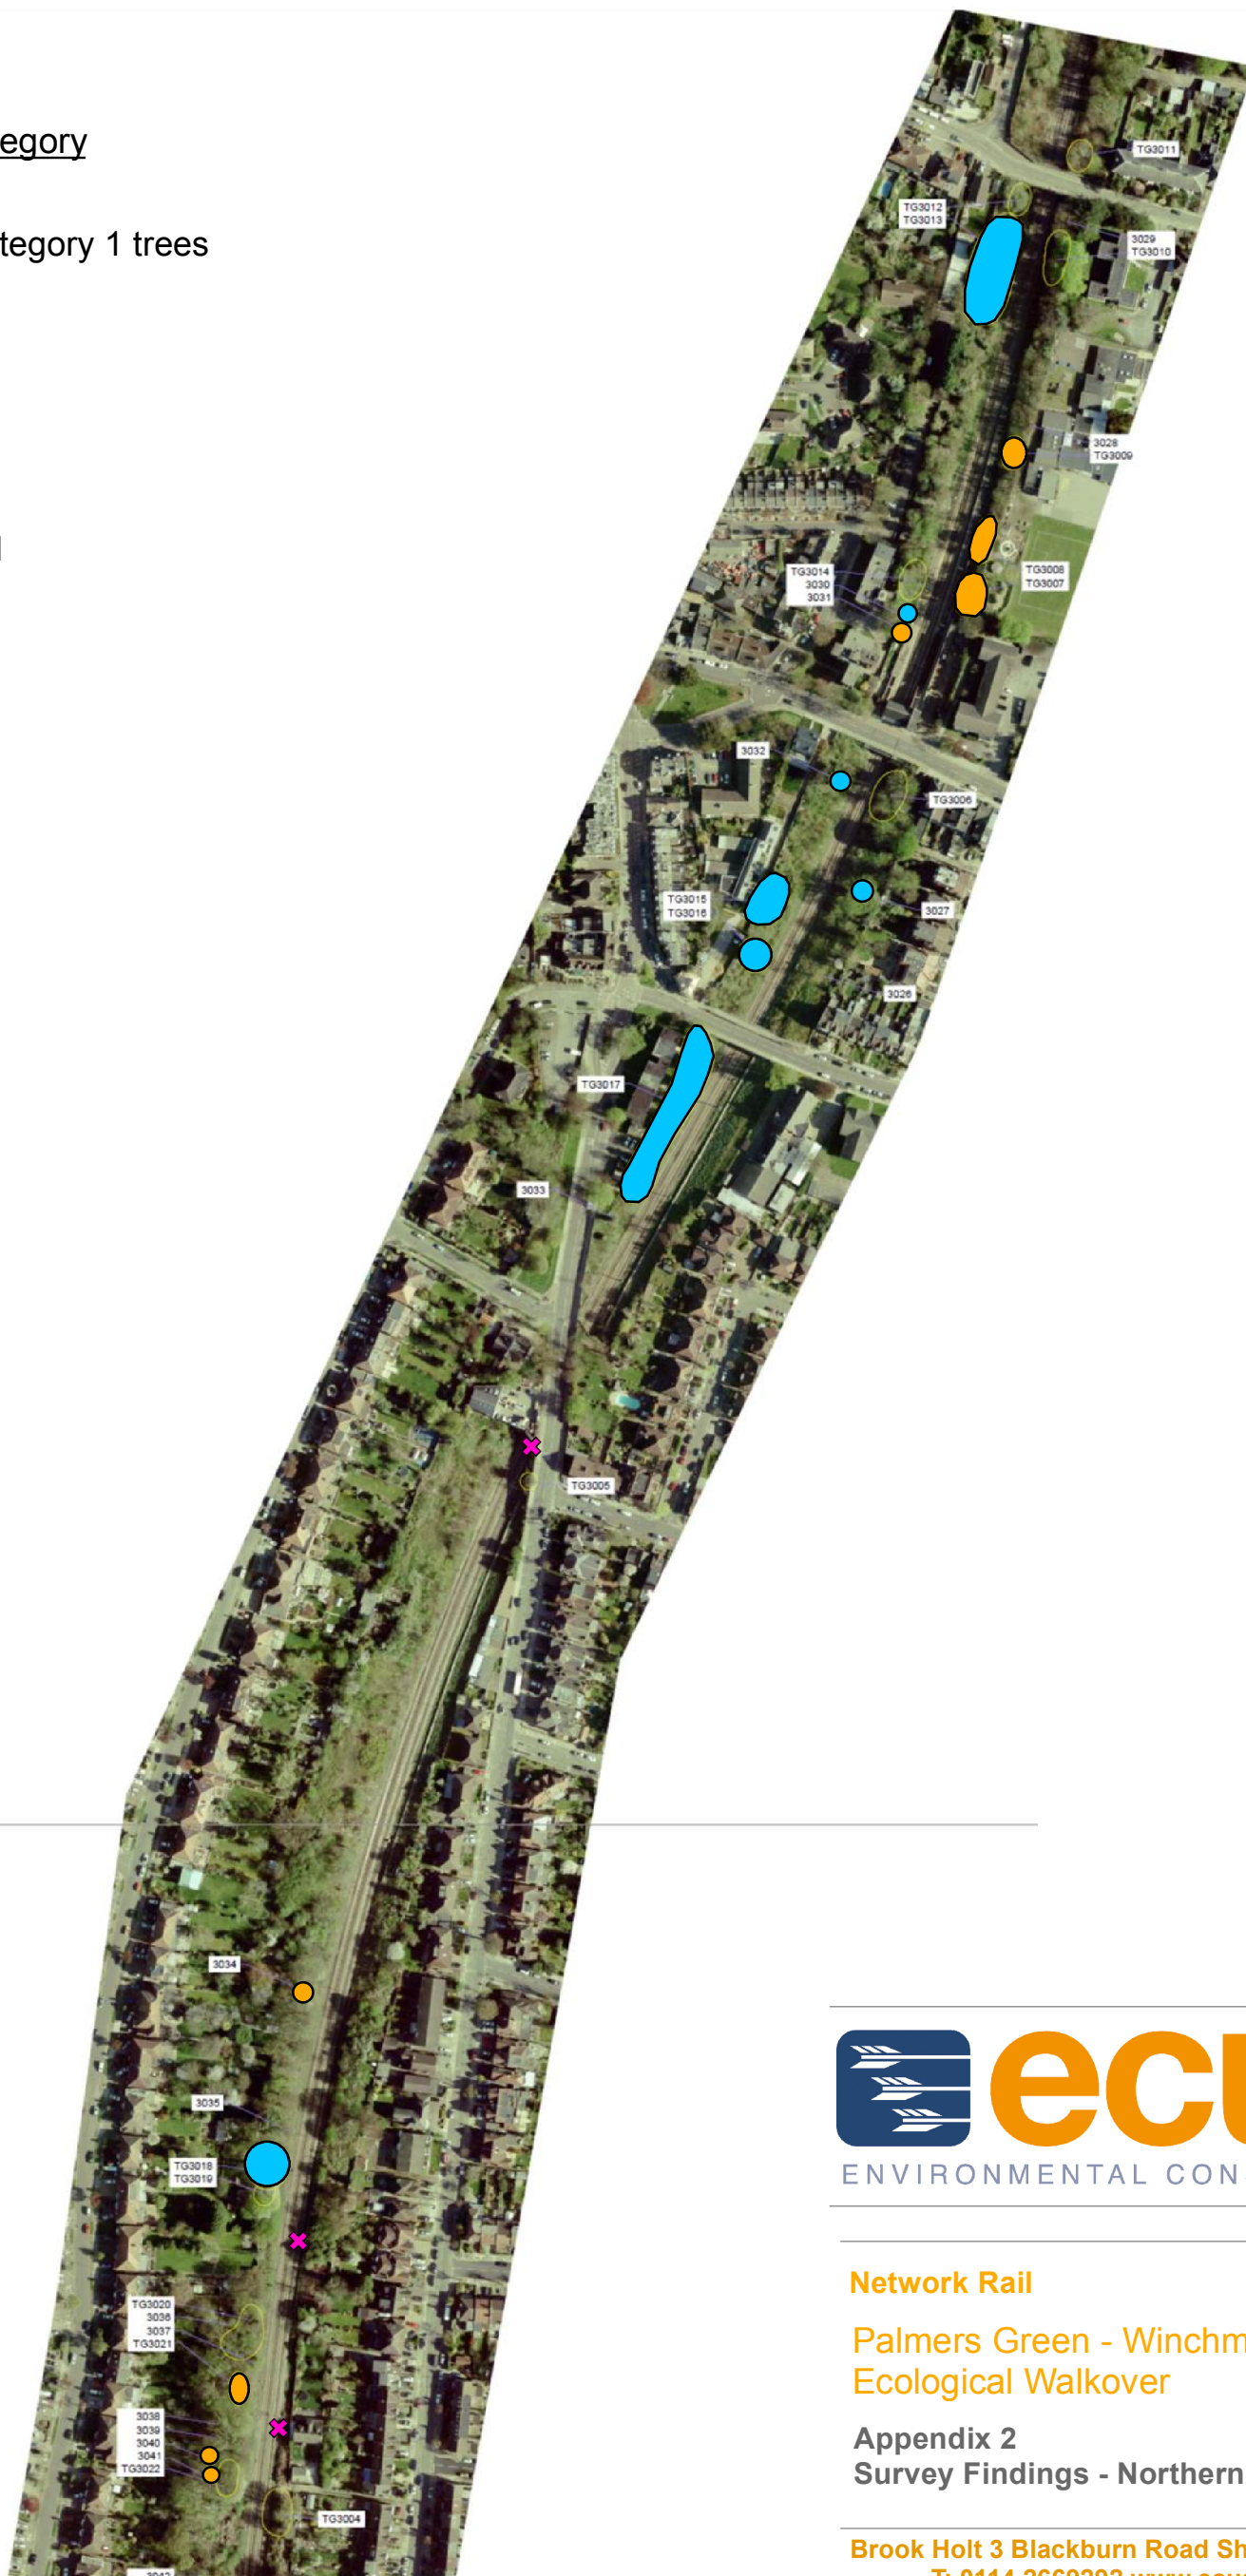
Appendix 2
Survey Findings - Northern Sheet

- Category 1* and Category 1 trees
- Category 2 trees

- ✘ Japanese knotweed

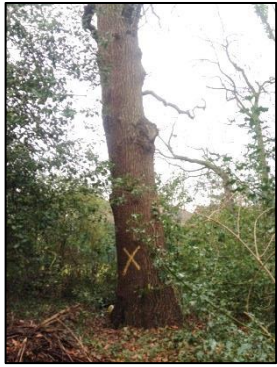
Tree	Location	Species	Tree category	Notes
3041	7m 18ch Down	Pedunculate oak	1*	Veteran tree. X6 woodpecker holes at 16 m on south side. Rotten knot hole at 6 m on east side. Hollow in dead wood at 14 m on east side. X 4 woodpecker holes at 12 m on west limb. Works appear not to impact on tree features but scope to be agreed with tree workers on day works to proceed.
3024	7m 5ch Up	Ash	1	Open knot hole at 10 m on south side of stem
TG3007	7m 63ch Up	Sycamore, holly, oak	1	Two trees with tear outs at 5 m in west facing section of stems, further inspection required
TG3008	7m 64ch Up	Sycamores x 3, pedunculate oak x 3	1	Tear out between 5-8 m in west facing section of stem, tear out at 6 m on north side of stem
TG3009	7m 65ch Up	Sycamores x 3	1	Southern tree with rot hollow at base of branch at 10 m on north side of stem
3031	Winchmore Hill St., back of platform D	Sycamore	1	Large open knot hole at 2.5 m on south side of stem

3041 - Pedunculate Oak - Category 1

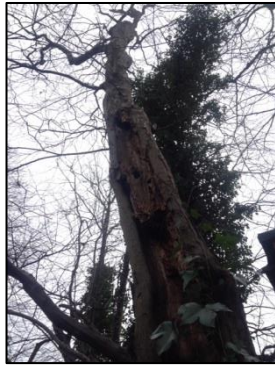
3034	7m 30ch Down	Pedunculate oak	1	Mature tree. Multiple rotten flush cuts on north side at 2, 4 and 6 m. Probable additional features when climbed.
TG3021	7m 20ch Down	Hornbeam x 2	1	Northern tree has tear out to 4 m leading into hollow stem - inspect from ladder. Wood pecker hole at 9 m on south side of north stem
3040	7m 19ch Down	Hornbeam	1	Rot hollow leading into side limb at 4 m on north side - further inspection required
TG3002	6m 62ch Down	Sycamore x 14	1	Tear outs/fire damage at base of number of trees - further inspection with a 6 mm endoscope required prior to felling
3001	6m 64ch Up	Sycamore	2	Dense ivy cover, probable squirrel drey in top
3002	6m 64ch Up	Sycamore	2	Inspected tear out at 2 m on north of stem
3003	6m 64.5ch Up	Ash	2	Dense ivy growth
3013	6m 65ch Up	Sycamore	2	Tight union - no cavity
3019	7m 1ch Up	Ash	2	Dense ivy growth
3023	7m 2ch Up	Sycamore	2	Dense ivy growth
3025	7m 6ch Up	Pedunculate oak	2	Large tree

TG 3021 - Hornbeam - Category 1

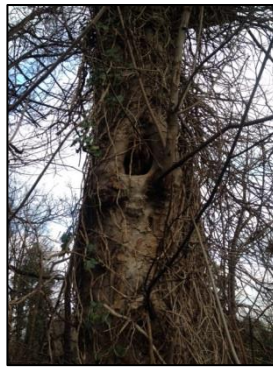
3031 - Sycamore - Category 1

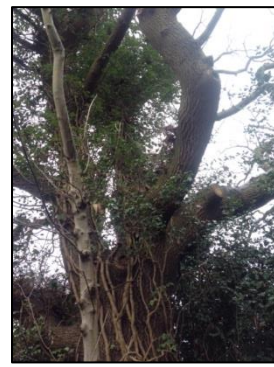
3034 - Pedunculate oak- Category 1

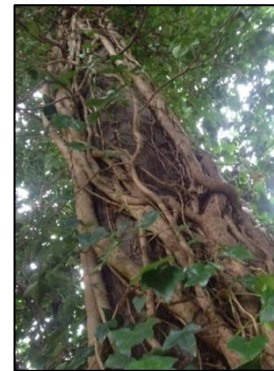
Example of dense ivy cover on trunk

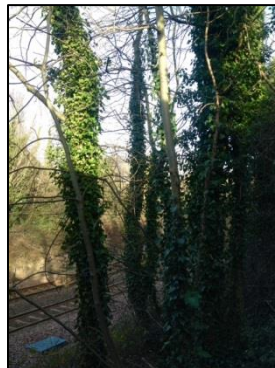
3016 - Ash - Category 2
