LISTED BUILDING CONSENT COMPLIANCE SUBMISSION

PRE-COMMENCEMENT CONDITION DISCHARGE APPLICATION

TRURO HOUSE

CONDITION ASSESSMENT AND
CONSERVATION RECOMMENDATIONS
FOR THE FIREPLACES AND
MAJOR DECORATIVE FEATURES

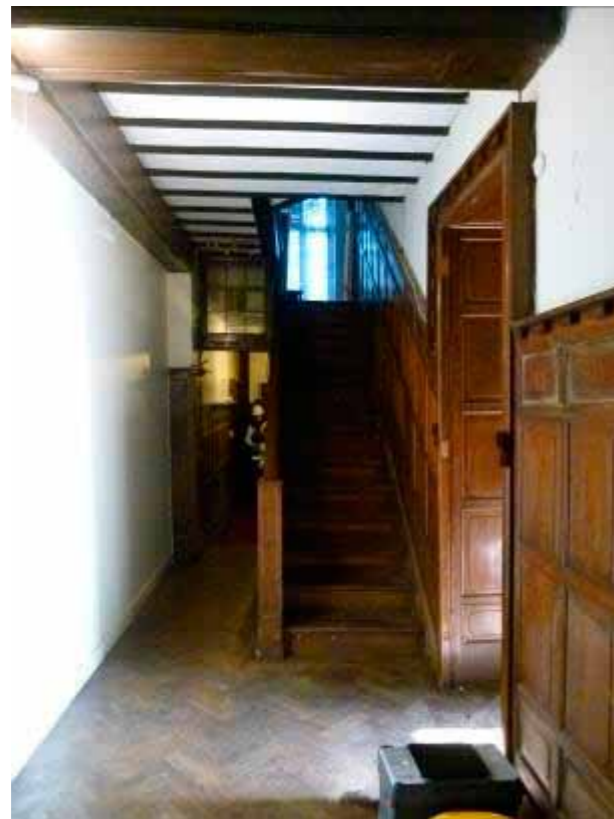
Signs of damage caused by damp were noted in various areas, including substantial rot to timber in the Entrance Hall.

Figure 5 Entrance Hall view toward stairs and east end entrance

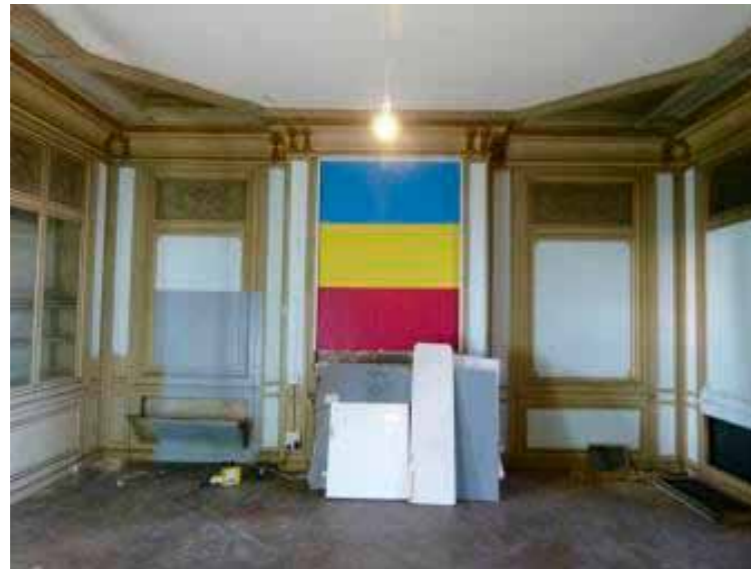
Figure 14 Drawing Room, east elevation, showing over painting and open panel

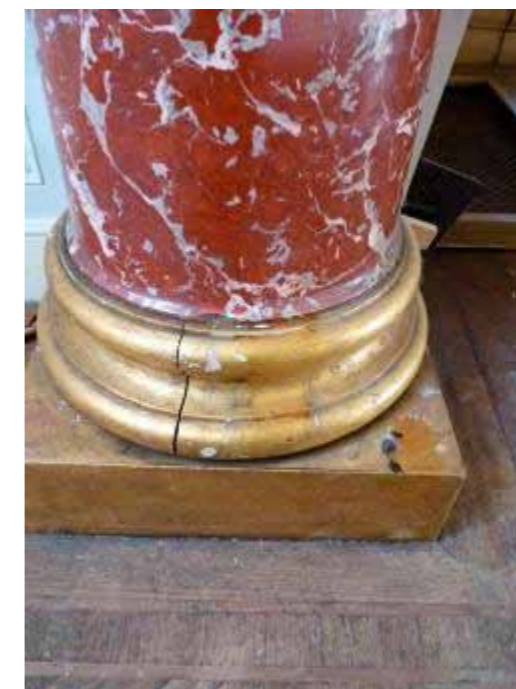
Figure 18 Drawing Room, south elevation, showing cleaning trial to scagliola columns base

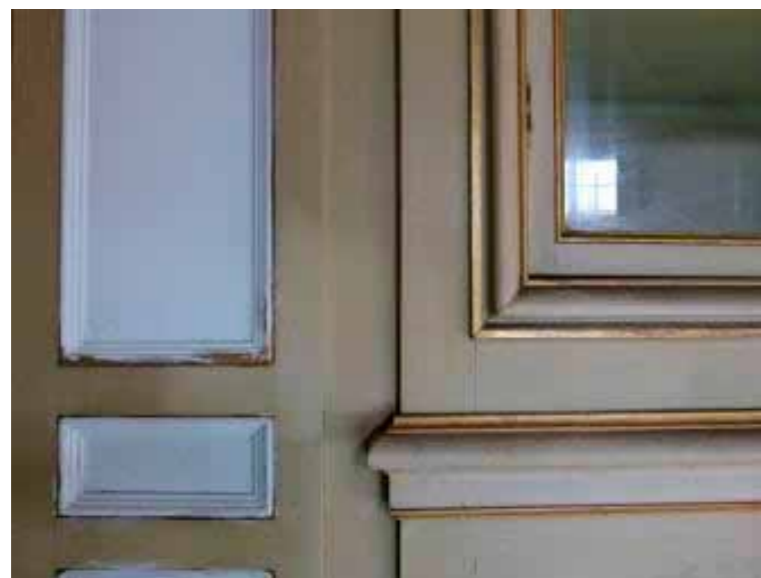
Figure 28 Drawing Room, area of wall and gilding cleaned, gilded beading appears brighter

- Remove surface dirt and debris with soft brushes and vacuuming.
- Clean all exposed original gilding with a weak 2-3% solution of tri-ammonium citrate and 1-2% solution of ammonium hydroxide carefully applied with cotton wool swabs (Figure 27). We recommend carrying out further trials before cleaning to establish methodology and materials.

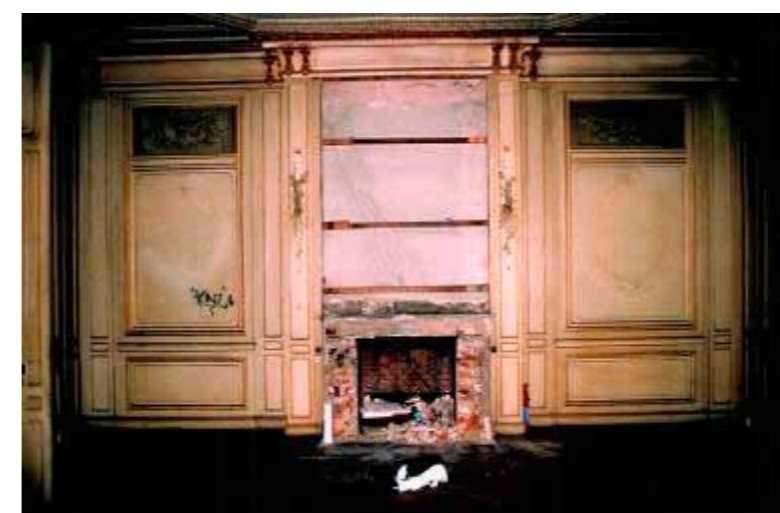
Figure 31 State of Drawing Room fireplace wall 1996

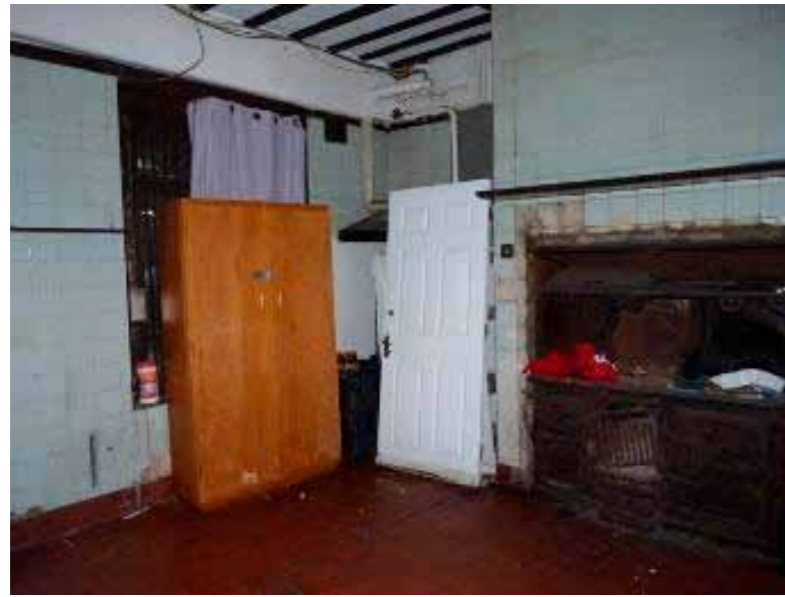
Figure 45 Kitchen north-west corner

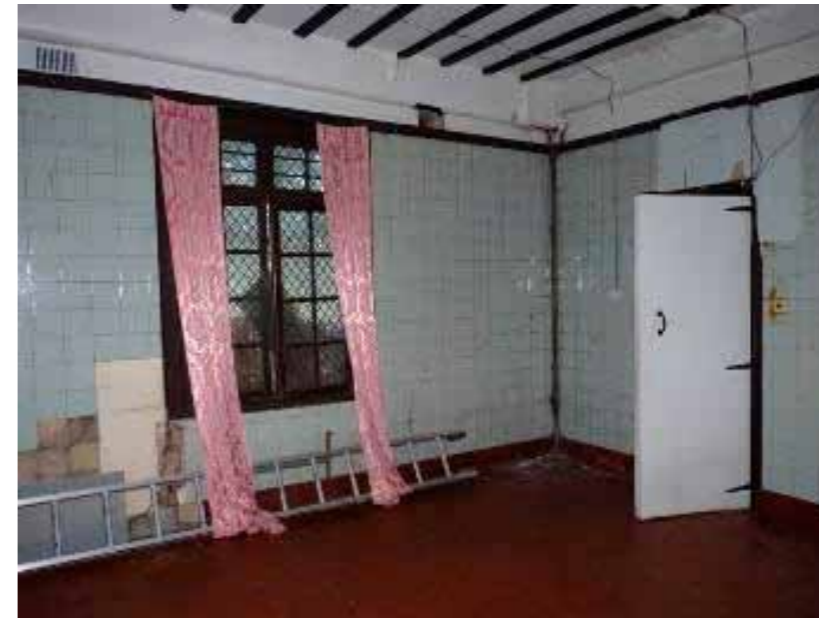
Figure 48 Kitchen south-east corner

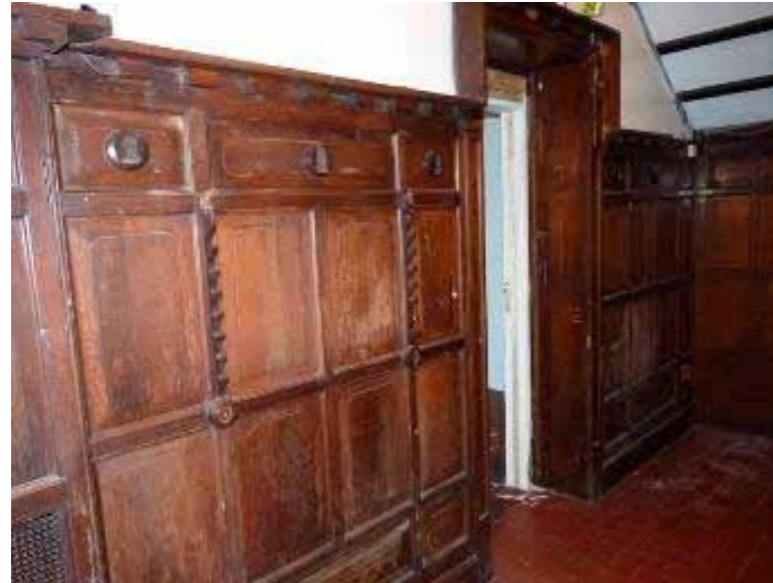
Figure 54 Back Hall showing south elevation

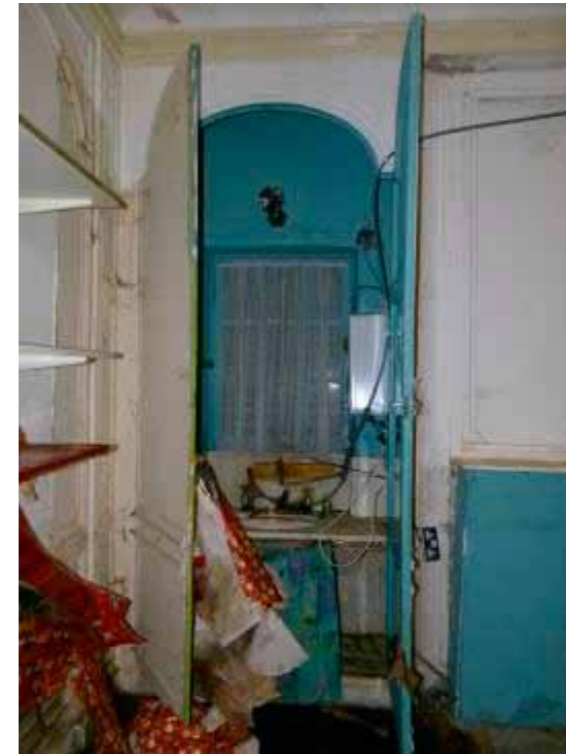
Figure 67 North East Bedroom, wash area with basin plumbed into cupboard

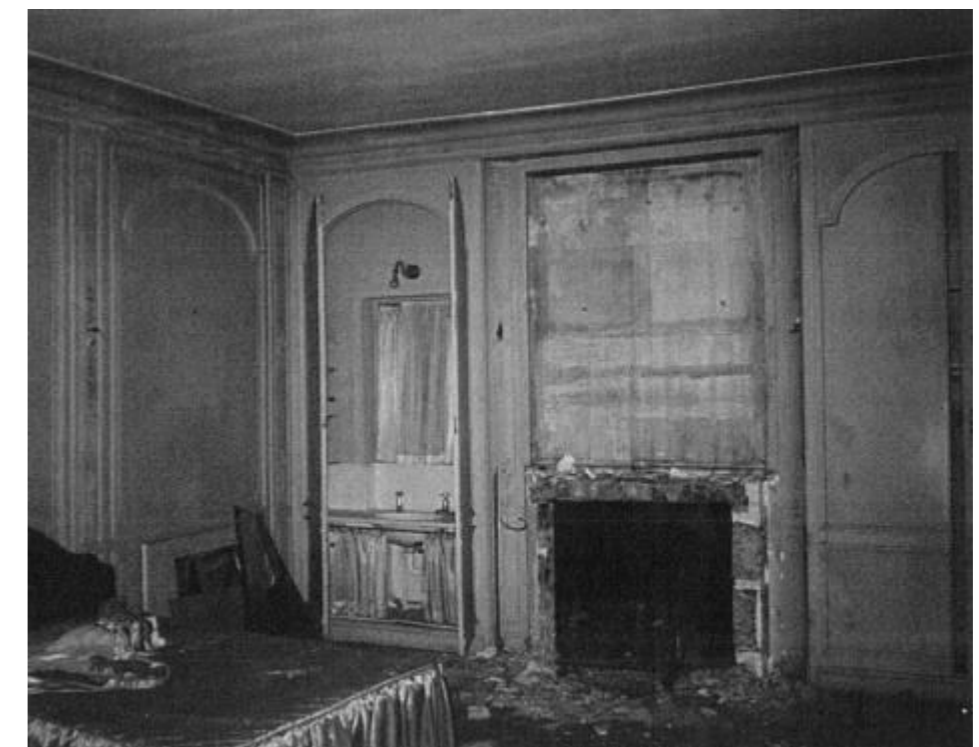
The fireplace (shown in an earlier photograph Figure 68) and mirror over-mantel, no longer remain, “but appears to have been rich and to have matched those in the south-west and north-east bedrooms, also stolen. The fireplace surviving in the north-west bedroom seems to date from this period and gives an approximation of the style”.

Figure 68 North East Bedroom, early image of room showing missing fire surround and over-mantel

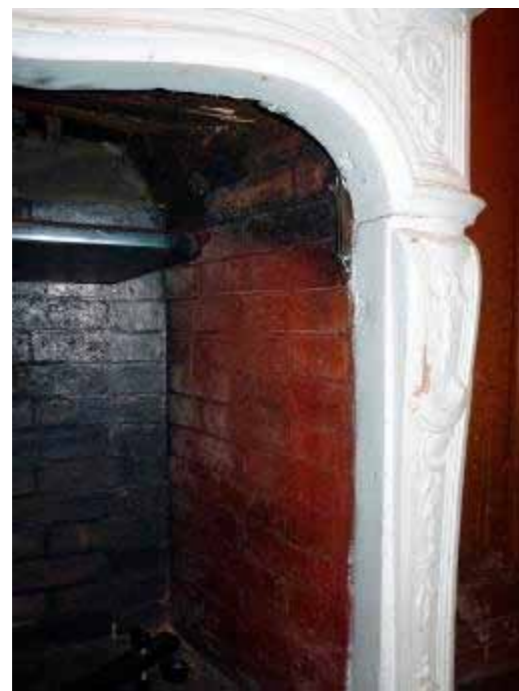
According to the English Heritage Report 2000, the ornately carved fireplace appears to be the only remaining from the late nineteenth century interiors “The fireplace surviving in the north-west bedroom seems to date from this period and gives an approximation of the style”⁸. The carvings of the stone fireplace are in relatively good condition but the finer details have been obscured by a distracting coating of modern white paint. This has been badly applied and in some areas is covering the brick returns immediately adjacent to the fire surround (Figure 87).

Figure 87 North West Bedroom, detail of fire surround showing over-paint

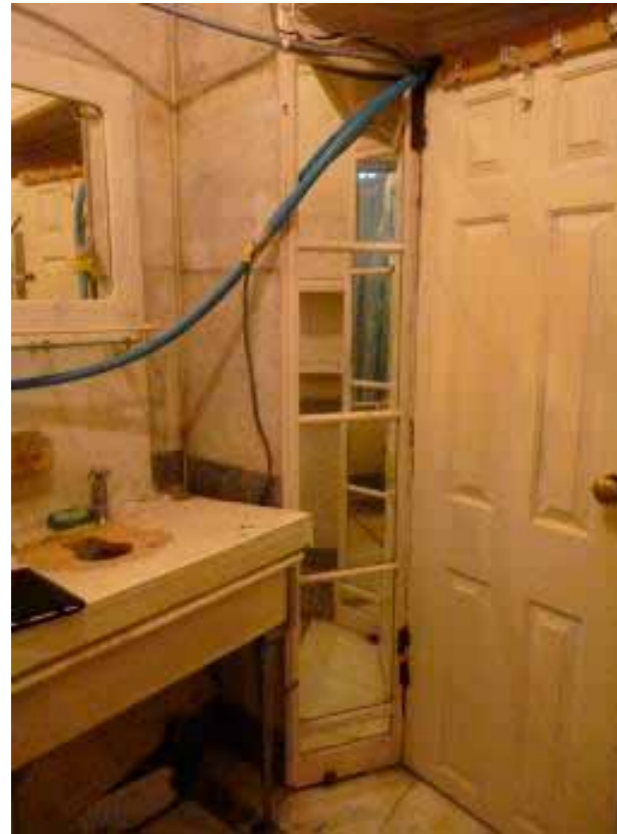
Figure 94 Bathroom, north east corner

- Remove dirt and reduce much of the staining with conservation-grade cleaning products such as V&A mix and Prelim polishing cream (as detailed before).
- We recommend carrying out further trials to establish the most suitable cleaning method for reducing staining and soiling without damaging the polished surfaces.
- Many interventions such as silicone sealants and adhesives will need to be removed. Carry out further trials to establish best methods and materials for cleaning other surfaces such as chrome and stainless steel fixings.

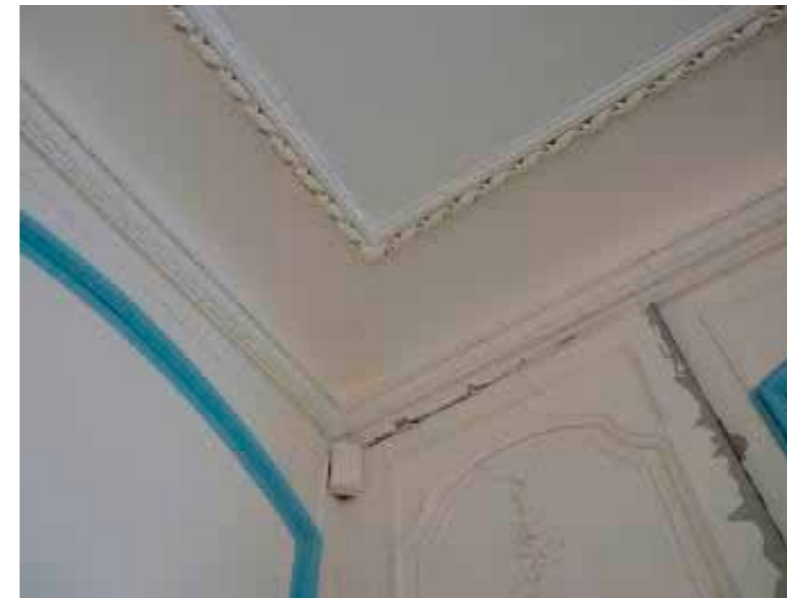
Figure 106 South West Bedroom, detail of panelling and moulding in north east corner

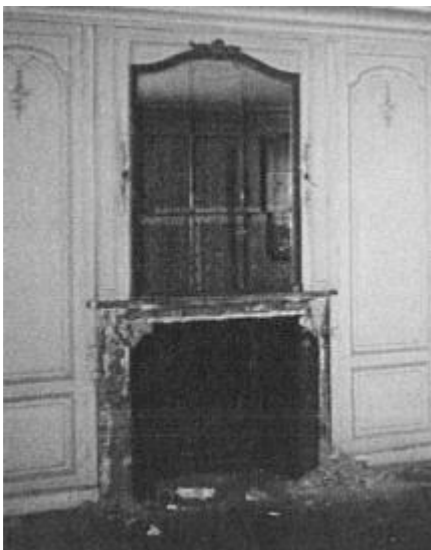
Figure 110 South West Bedroom, early photograph showing over-mantel mirror, the fire surround is missing
