LISTED BUILDING CONSENT COMPLIANCE SUBMISSION

PRE-COMMENCEMENT CONDITION DISCHARGE APPLICATION

TRURO HOUSE

CONDITION ASSESSMENT AND
CONSERVATION RECOMMENDATIONS
FOR THE FIREPLACES AND
MAJOR DECORATIVE FEATURES

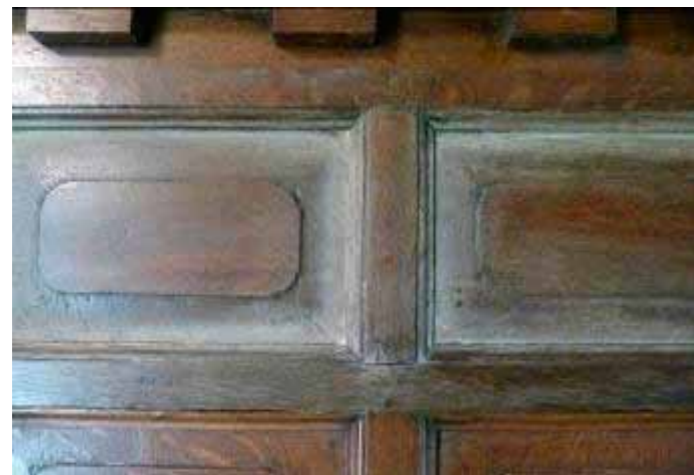
Figure 6 Entrance Hall showing fading to panelling over closed side of door to Drawing Room

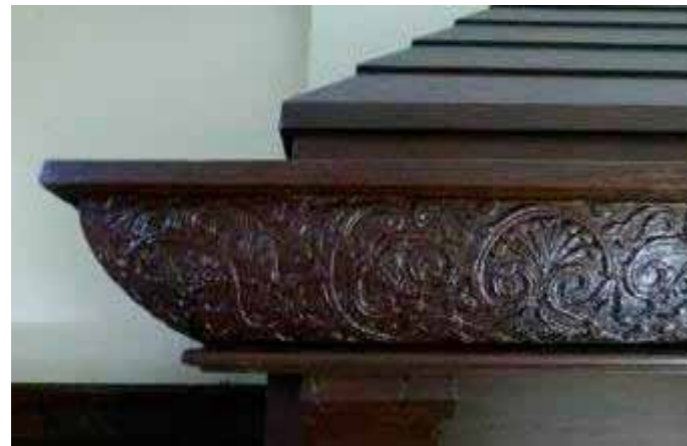
A large gothic style fireplace dominates the north elevation of the now enclosed Living Hall. The chimneypiece has a high-ridged hood with ornate timber carvings on the mantel. Red and pink over-paint has been applied to the fire back and hearth and the carved timber has a heavy varnish coating.

Figure 11 Living Hall, carved timber fireplace mantel

- Clean timber elements with white spirit applied over surfaces using lint-free cotton rags.
- Apply light coating of Microcrystalline wax over cleaned timber and buff to a soft sheen.
- Remove over-paint from fire back and hearth with proprietary paint stripper.
- Apply protections to all areas of fireplace and parquet flooring prior to stripping, taking care not to affect timber elements.
- Remove metal hood from mantel and replace internal hood to match original (Figure 9).
- All replacement fireplace fixtures and fittings should be matched to the original as closely as possible.

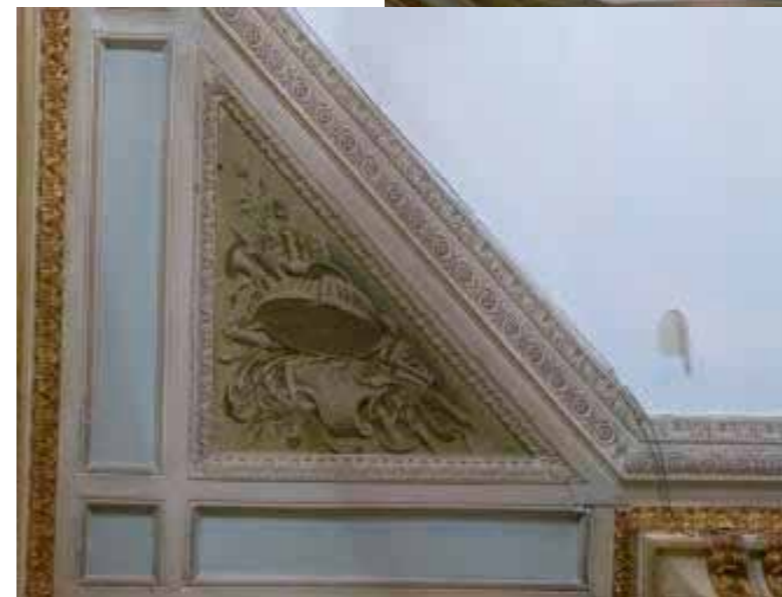
Figure 20 Drawing Room, corner ceiling panel with grisaille painting

The paintings are covered with a layer of surface and more ingrained dirt and also appear to have been varnished. This varnish layer has discoloured over time and is further obscuring the detail and subtle colours of the grisaille.

- We recommend that all conservation cleaning be carried out by trained conservators.

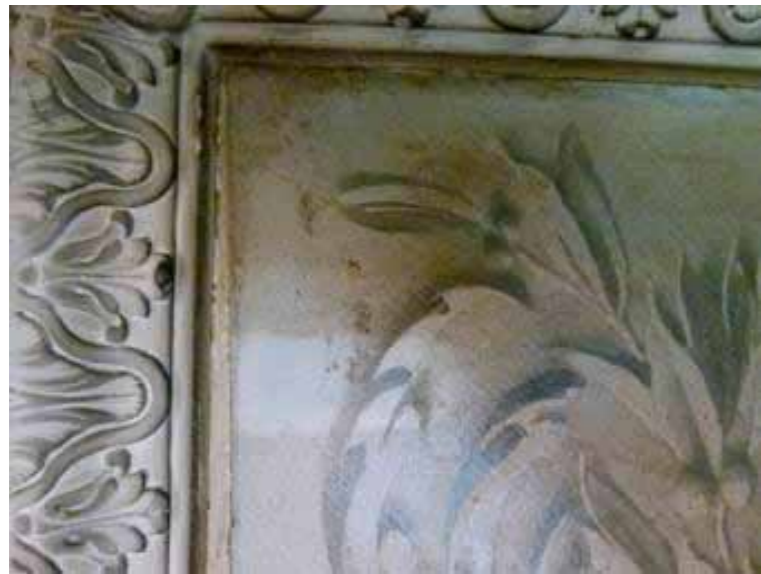
Figure 23 Drawing Room, cleaning trial to ceiling panel grisaille reveals subtle tones of original painting

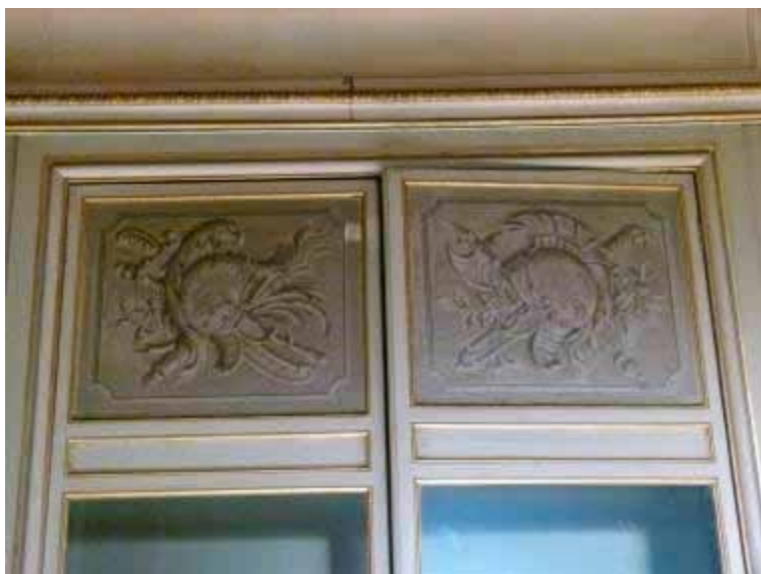
Figure 24 Drawing Room, wall panel above cupboards showing cleaning trial

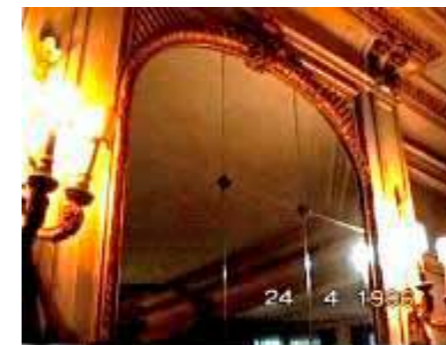
The fireplace and mirror over-mantel shown in an earlier photograph (Figure 30) no longer remain, “but appears to have been rich and to have matched those in the south-west and north-east bedrooms, also stolen. The fireplace surviving in the north-west bedroom seems to date from this period and gives an approximation of the style.”⁵

Figure 30 Drawing Room, mirror and over-mantel still present in April 1996

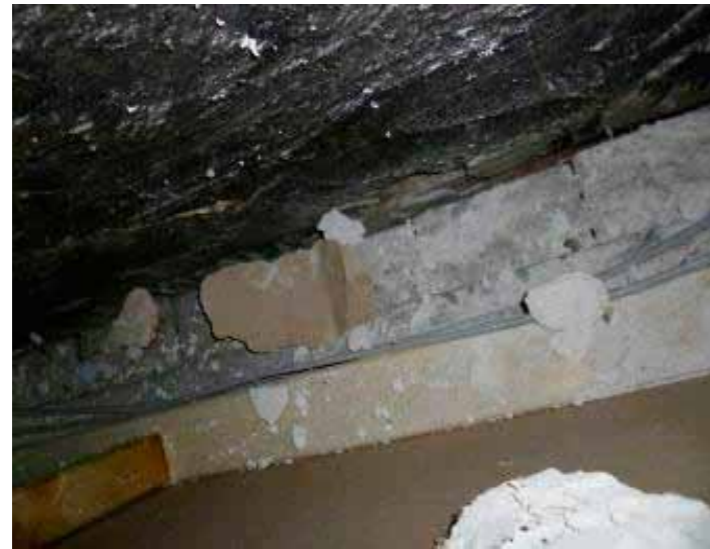
Figure 37 Dining Room, behind the plasterboard shows plaster walls and no panelling

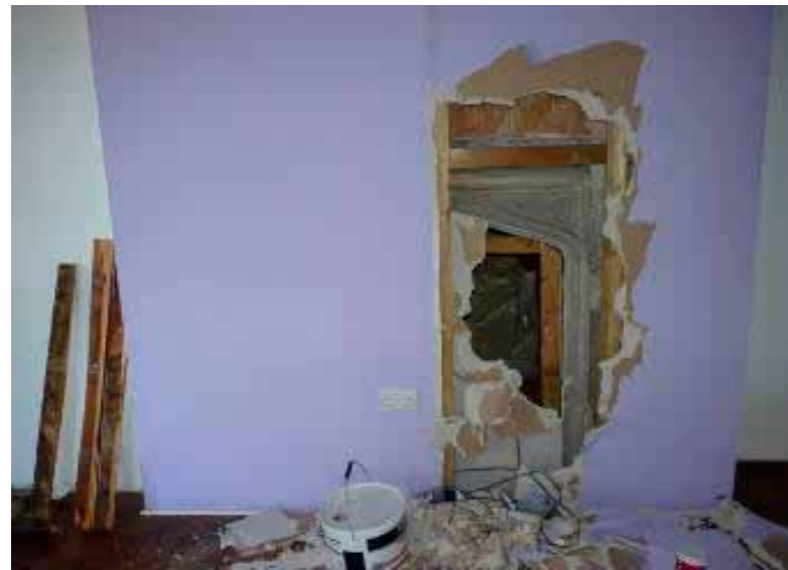
The original Dining Room fireplace had an ornately carved timber over-mantel with carved, stone surround and brick hearth. Old images of the fireplace in its original condition indicate a glass baffle at the top of the fire opening, presumably to improve draw: this is no longer in place. The timber over-mantel as with much of the panelling in the room is also longer present and the brick hearth is damaged. The stone surround still appears to be in relatively good order (viewing was restricted). However what remains of the fireplace is heavily soiled and would benefit greatly by careful conservation cleaning.

Figure 42 Dining Room, plasterboard removed to reveal original fireplace

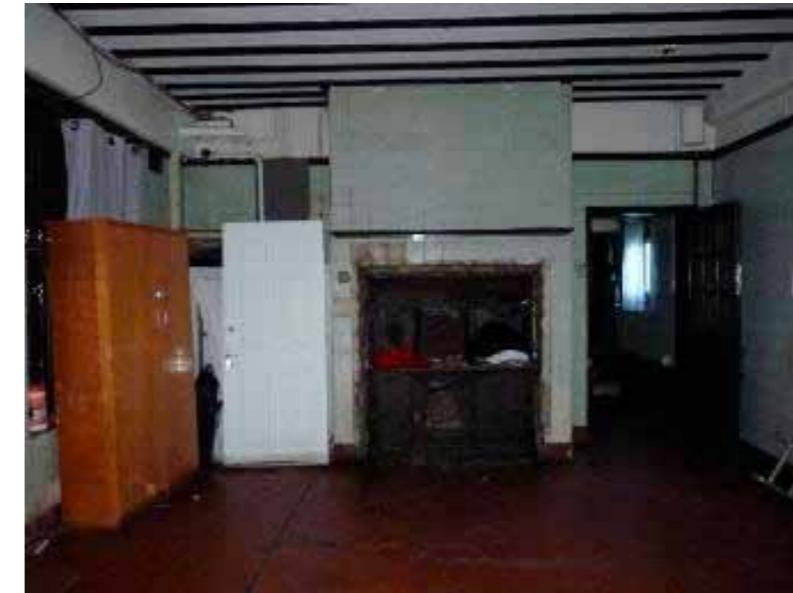
Figure 43 Kitchen, north elevation showing range

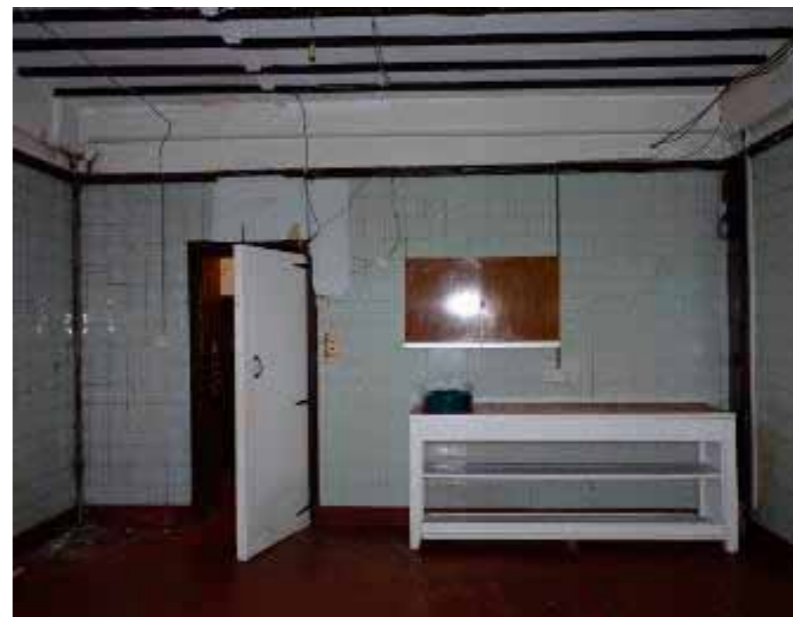
Figure 44 Kitchen, south elevation

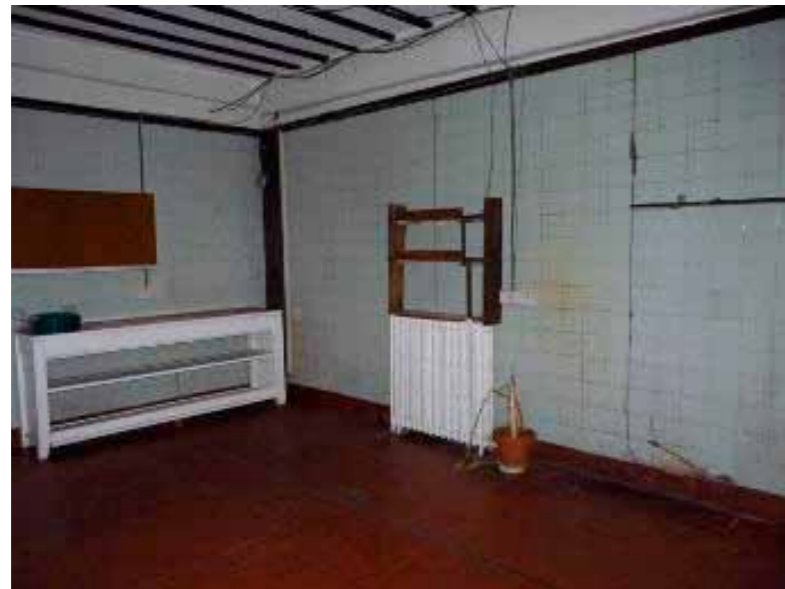
Figure 46 Kitchen, south-west corner

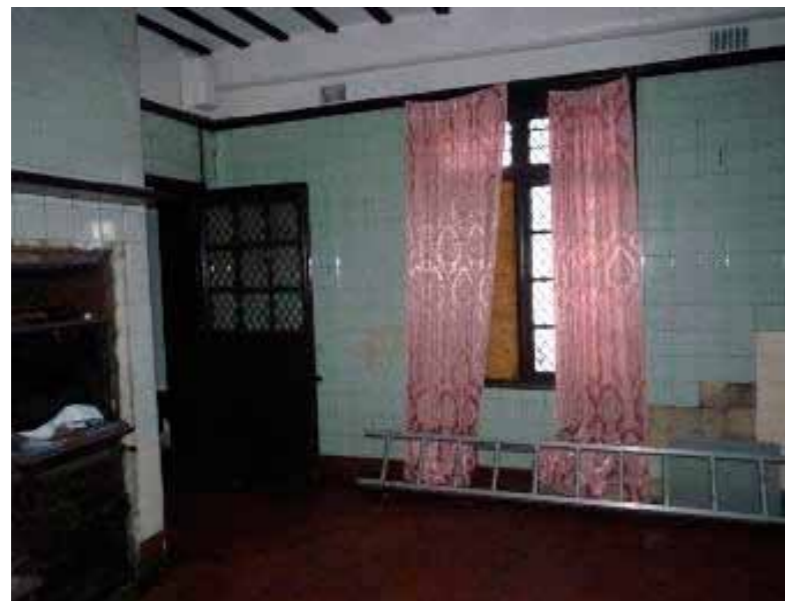
Figure 47 Kitchen, north-east corner

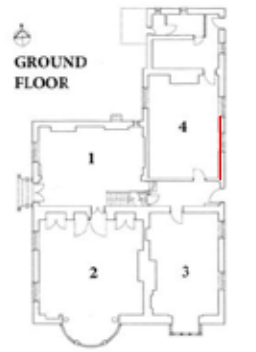
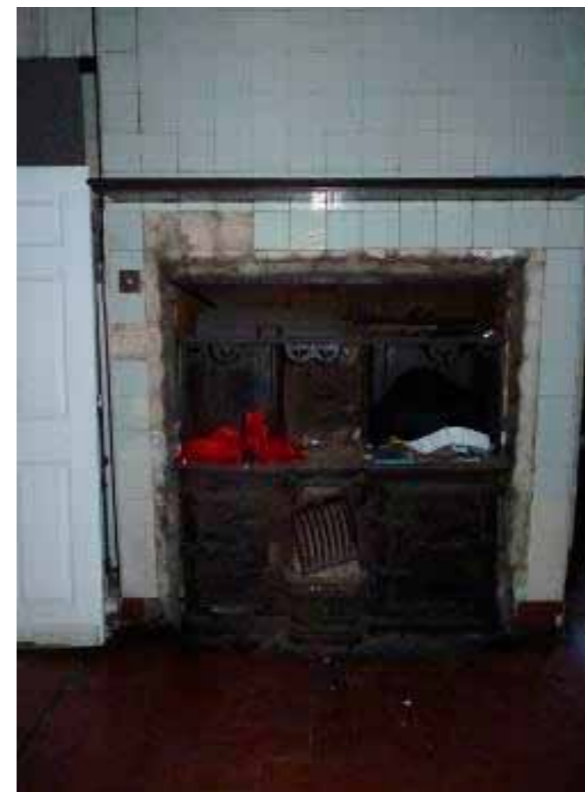
Figure 49 Kitchen, Gold medal Eagle Range

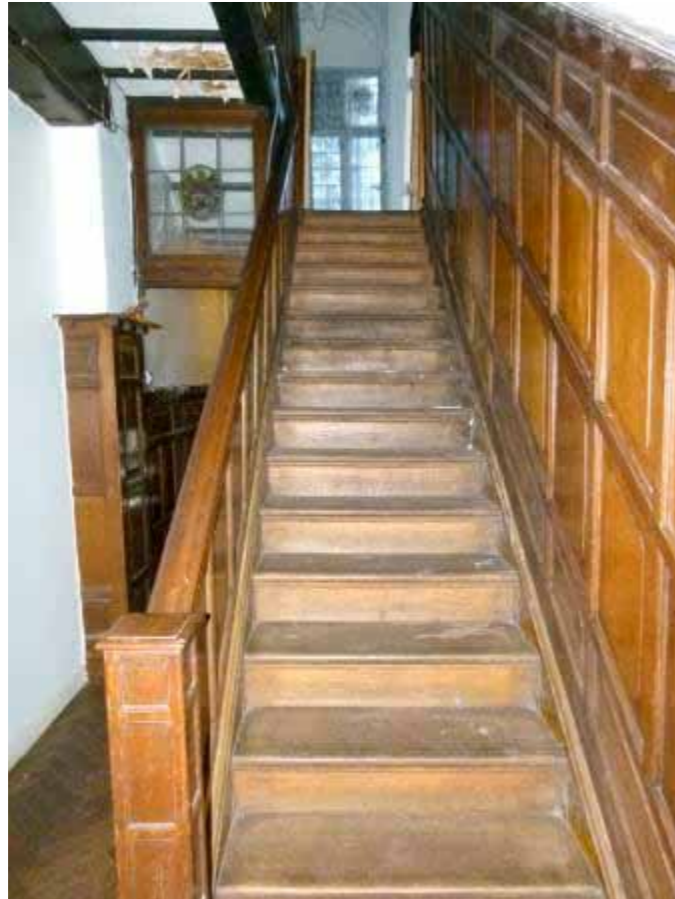
Figure 50 Stairs, showing heraldic stained glass inserts to leaded lights

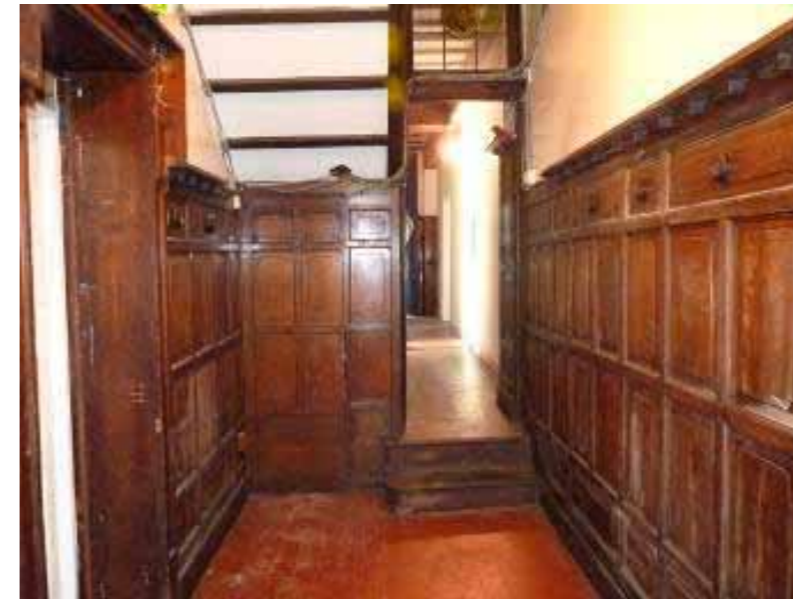
Figure 51 Back hall facing west

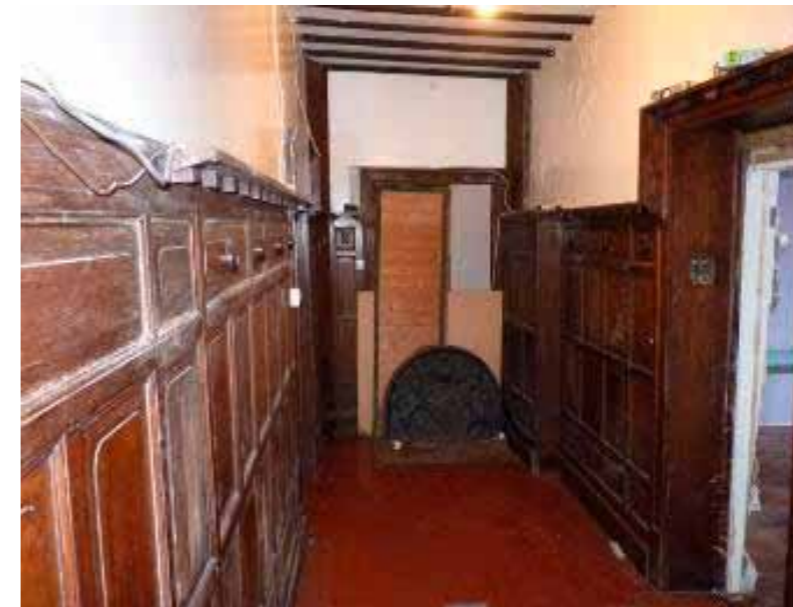
Figure 52 Back Hall facing east

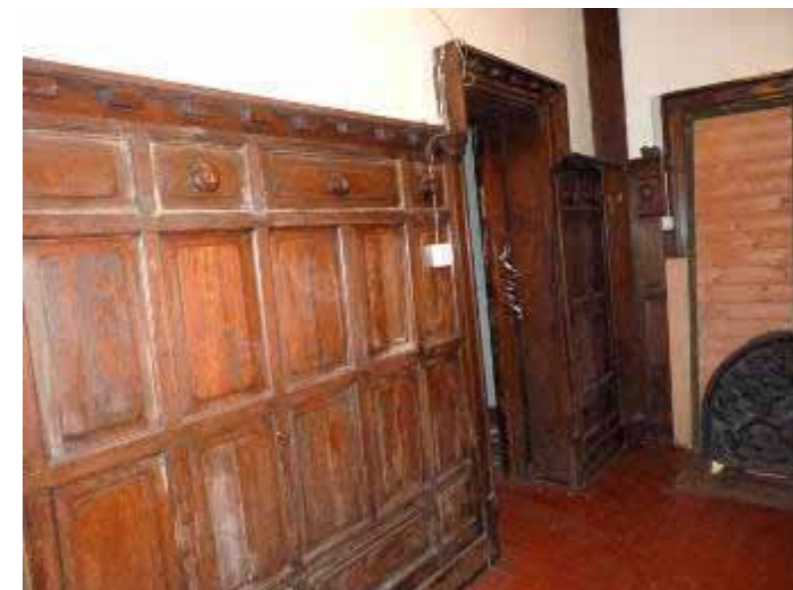
Figure 53 Back Hall showing north elevation and timber wall panelling

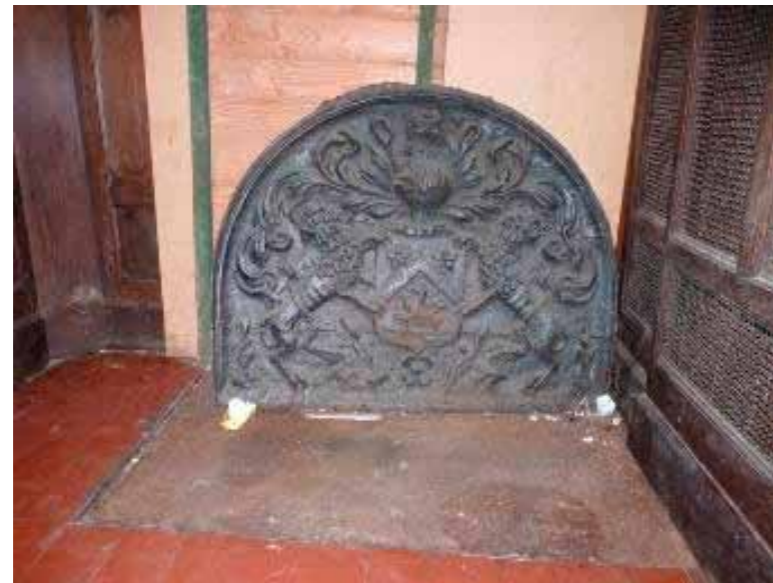
Figure 55 Back Hall, ornate fireback bearing coat of arms

- All original cast fire backs which remain in the property should be dusted with stiff brushes to remove loose rust deposits, surface dirt and debris.

- Iron corrosion on the fire backs should be treated with a rust converter, we recommend using *Fertan Rust Converter*.

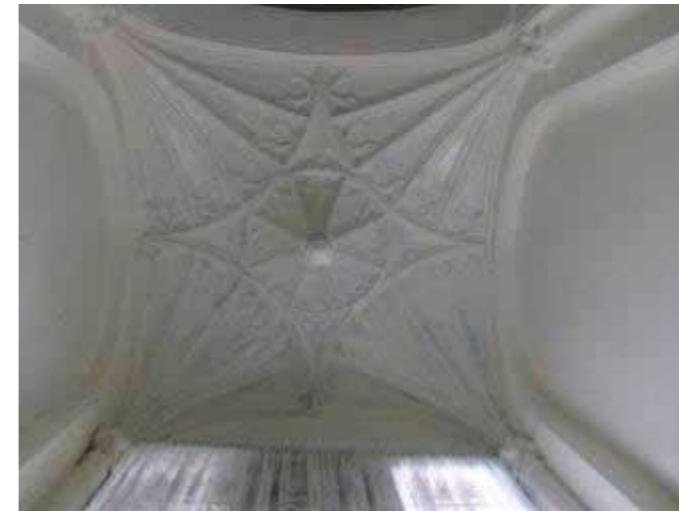
Figure 57 East end lobby, ribbed vaulted ceiling

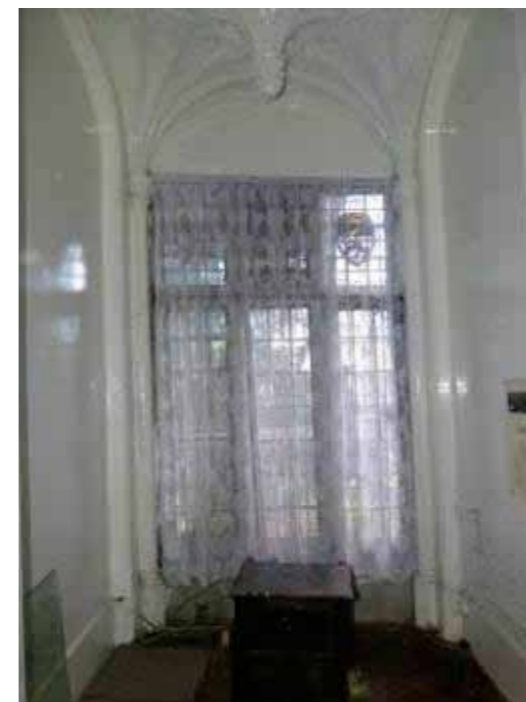
The columns either side of the window are showing problems associated with the ingress of water. Cracks and blistering to the paintwork were noted along with mould. The flooring throughout is showing signs of general wear and tear and would benefit from localised repairs, cleaning and re-finishing.

Figure 58 East end lobby area, note heraldic stained glass window inserts

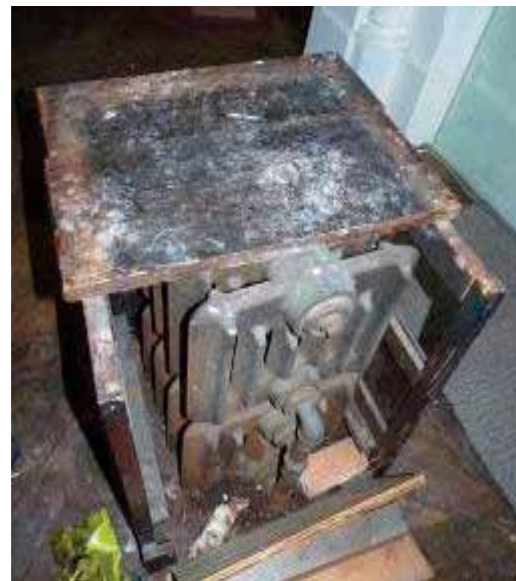
Figure 60 East end lobby, radiator and cover on landing

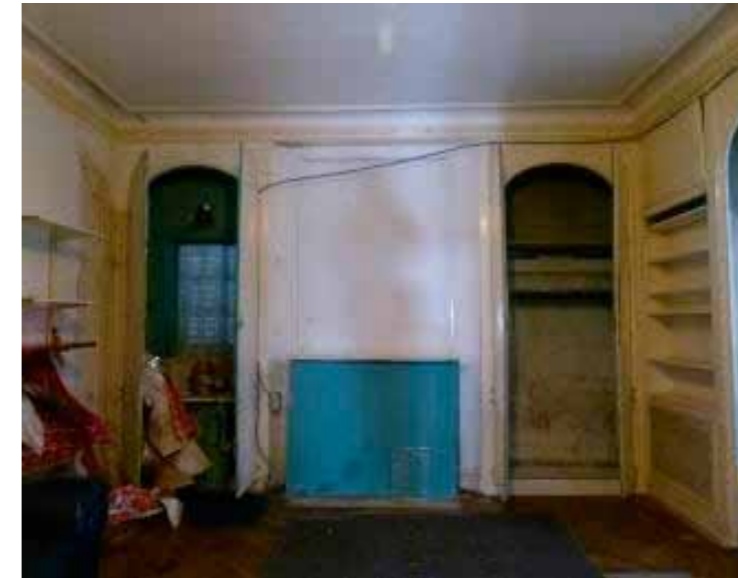
Figure 61 North East Bedroom, north elevation showing wash area in left hand cupboard

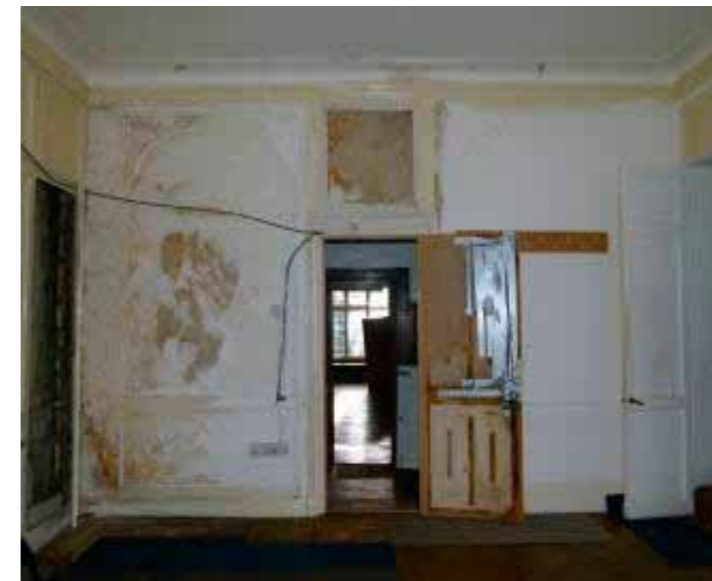
This room has suffered extensively from damp and water ingress. Flaking, blistering paint and plasterwork as well as mould were noted throughout, but particularly in the south east corner of the room.

Figure 62 North East Bedroom, south elevation showing large area of wall affected by damp

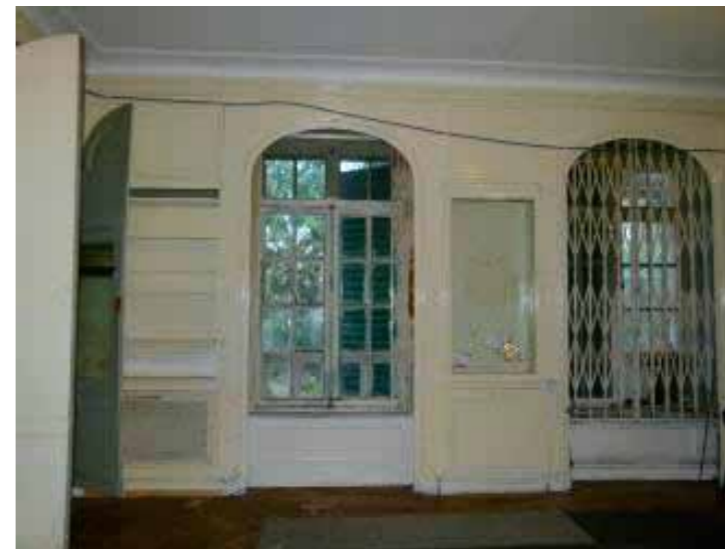
Figure 63 North East Bedroom, east elevation (north)

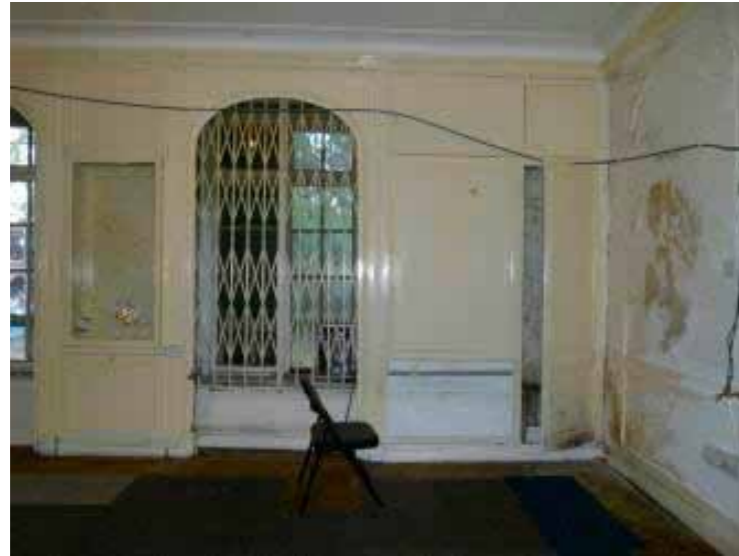
Figure 64 North East Bedroom, east elevation (south)

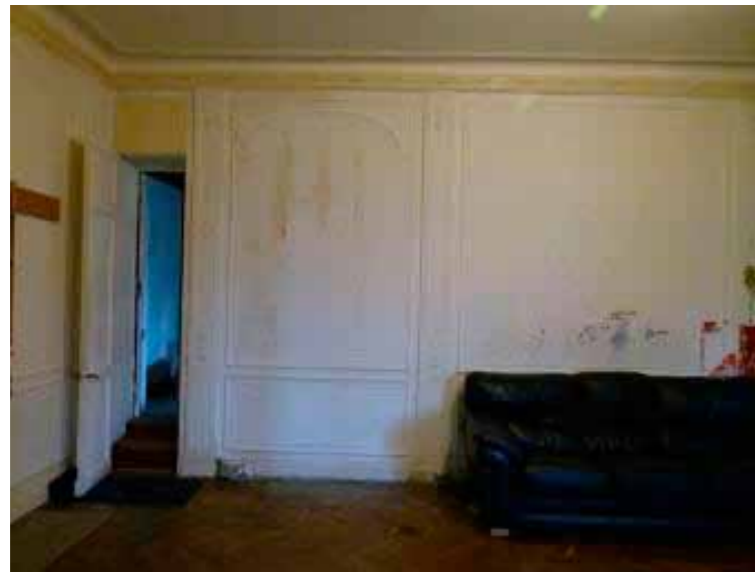
Figure 65 North East Bedroom, west elevation (south)

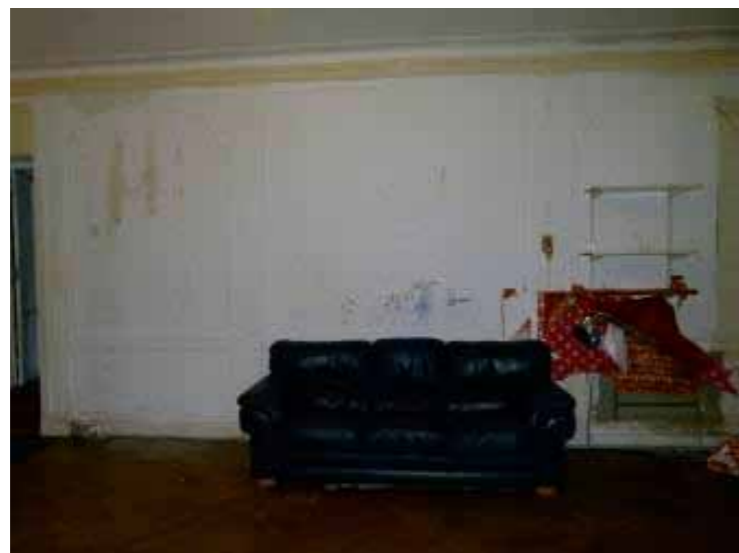
Figure 66 North East Bedroom, west elevation (north)

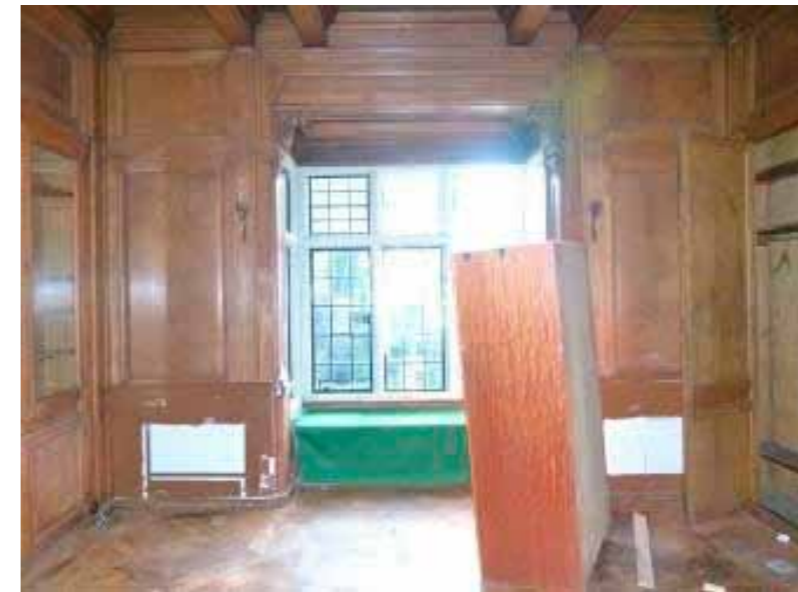
The walls and ceiling of this room are entirely panelled. The ceiling panels form sections containing painted designs in the Arts & Crafts style. The same style and colours of the applied decoration appear on the high hood of the fireplace. A plumbed in wash stand has been built within a cupboard/niche to the right of the door on the north elevation. On the other side of the doorway an open staircase leads up to the adjoining south-west bedroom (Figure 72). The parquet flooring throughout but particularly near the south window, is showing signs of excessive wear and tear and would benefit from cleaning and re-finishing.

Figure 71 Normandy Bedroom, towards south elevation

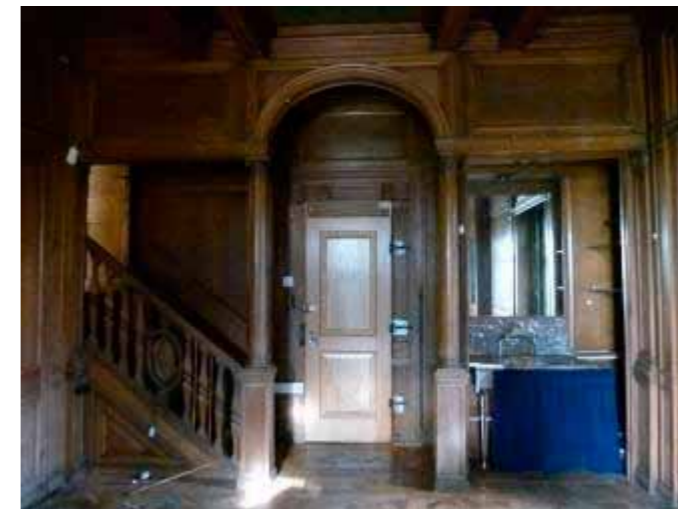
Figure 72 Normandy Bedroom, north elevation showing stairs to adjoining bedroom and wash area

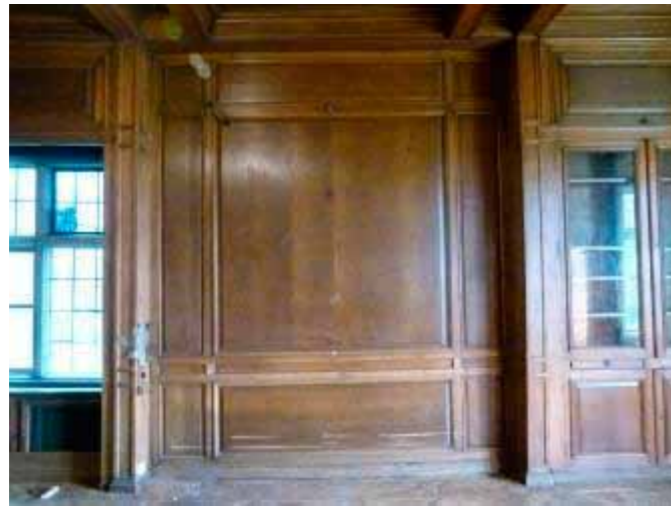
Figure 73 Normandy Bedroom, east elevation, mechanism for bell pull still remains on panelling

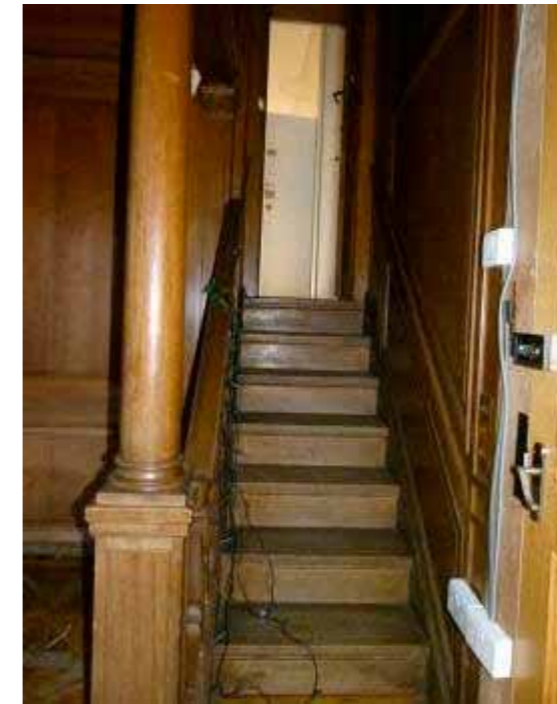
Figure 76 Normandy Bedroom, stairs rising to adjoining South West Bedroom

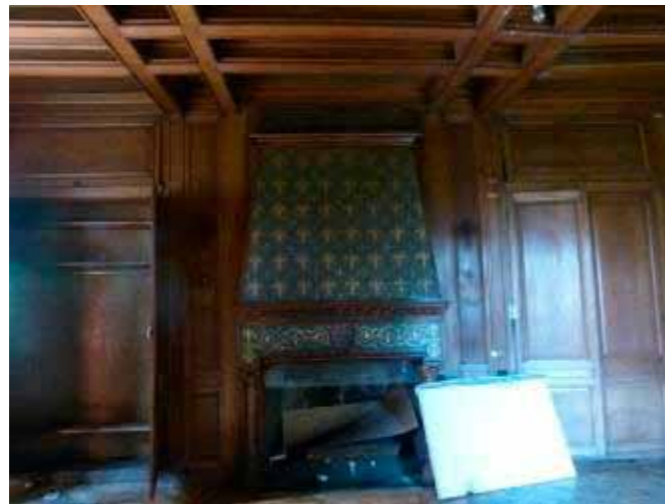
Figure 74 Normandy Bedroom, west elevation showing arts and crafts style fireplace

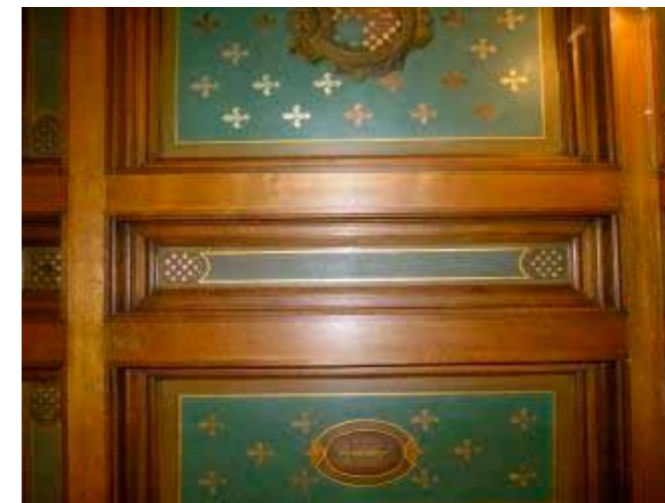
Figure 78 Normandy Bedroom, detail of applied decoration within ceiling panels

The painted ceiling panels, fire surround and over-mantel are in relatively good condition with no notable areas of loss or damage recorded during the site visit. A layer of surface dirt has slightly dulled the colour scheme. It is probable that the original scheme was given an aged appearance.

- The applied decoration within this room would benefit from light cleaning with specialist dry-cleaning or soot sponges.
- We recommend further trials are carried out to establish best methods and materials before cleaning commences.

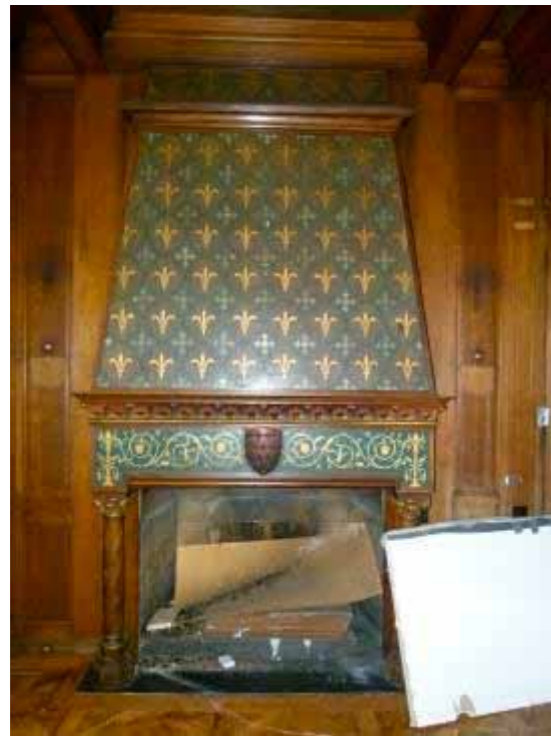
The carved timber fire surround, mantel and high hood all have painted details. They are in good condition with only surface soiling. The cast iron fire back was not in place at the time of viewing but is visible in earlier photographs. There is a transparent screen fixed along the top edge of the fire opening, presumably to improve draw.

Figure 79 Normandy Bedroom, detail of fireplace showing arts and crafts style applied decoration

- Remove debris from the fireplace area and vacuum all exposed surfaces.
- Clean applied decoration with specialist dry-cleaning or soot sponges.
- More stubborn, ingrained dirt can be removed or reduced with V&A mixture carefully applied over the painted surfaces with cotton wool swabs. Rinse cleaned areas with white spirit.
- All re-instated features should be closely matched to the original and early photographs and documentation consulted where possible.

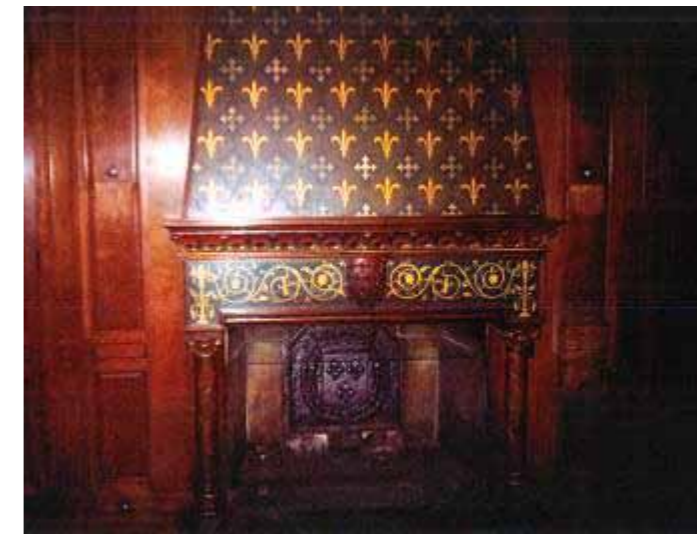
Figure 80 Normandy Bedroom, Early image of fireplace showing cast fireback

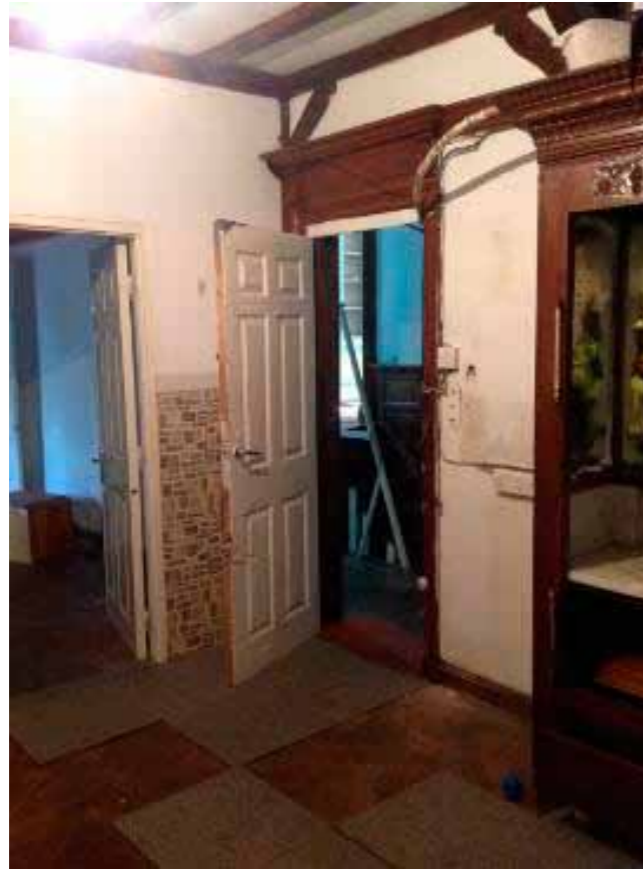
Figure 82 North West Bedroom, south elevation showing door architrave and false wall

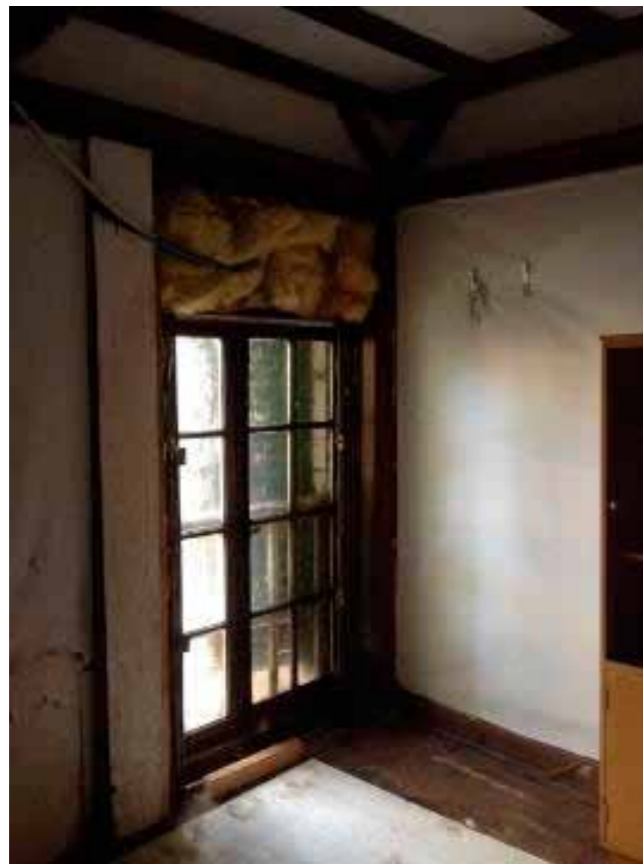
Figure 83 North West Bedroom, north-west corner

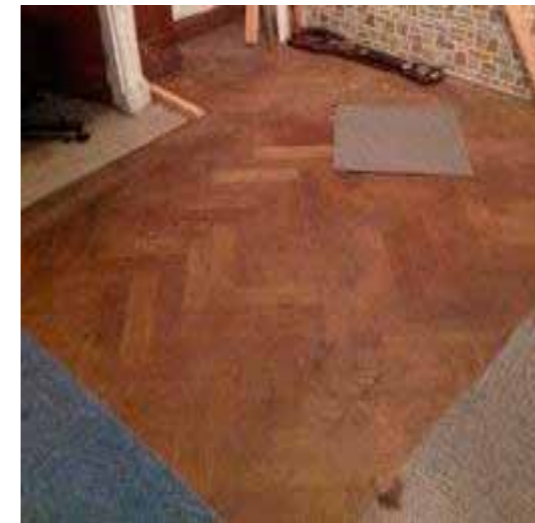
Figure 84 North West Bedroom, parquet flooring

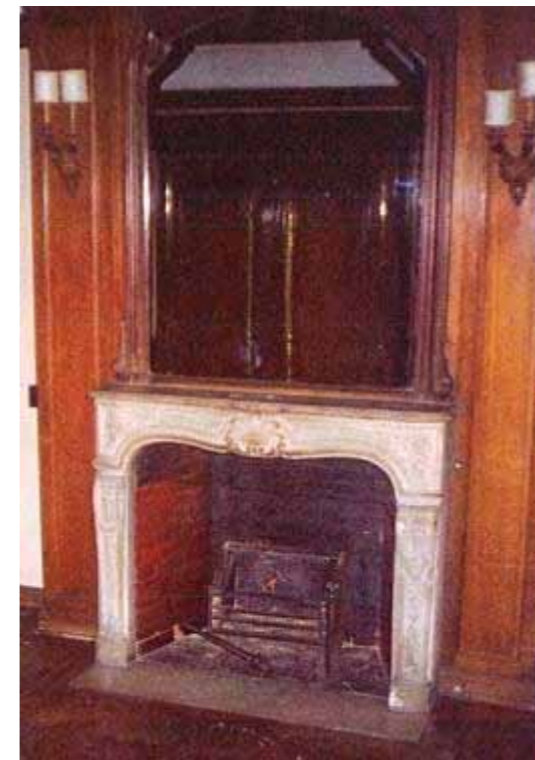
Figure 85 North West Bedroom, early image of fireplace and over-mantel mirror

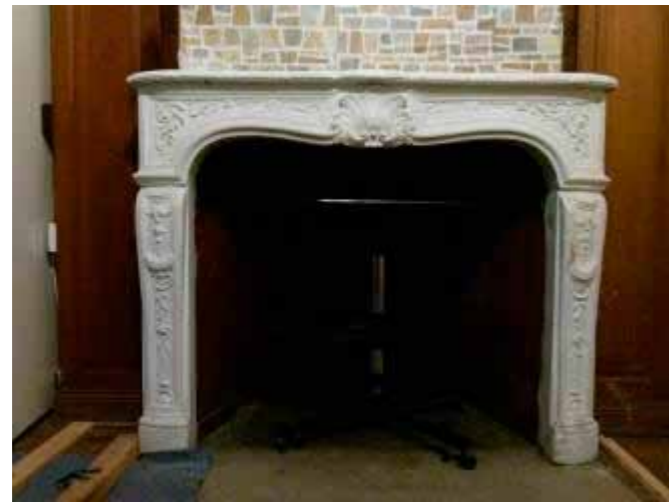
According to the English Heritage Report 2000, the ornately carved fireplace appears to be the only remaining from the late nineteenth century interiors “The fireplace surviving in the north-west bedroom seems to date from this period and gives an approximation of the style”⁸. The carvings of the stone fireplace are in relatively good condition but the finer details have been obscured by a distracting coating of modern white paint. This has been badly applied and in some areas is covering the brick returns immediately adjacent to the fire surround (Figure 87).

Figure 86 North West Bedroom, detail of marble fireplace

- Replacement marble should be matched as closely to the original. Repairs and fills should be pigmented or colour-matched to adjacent surfaces.

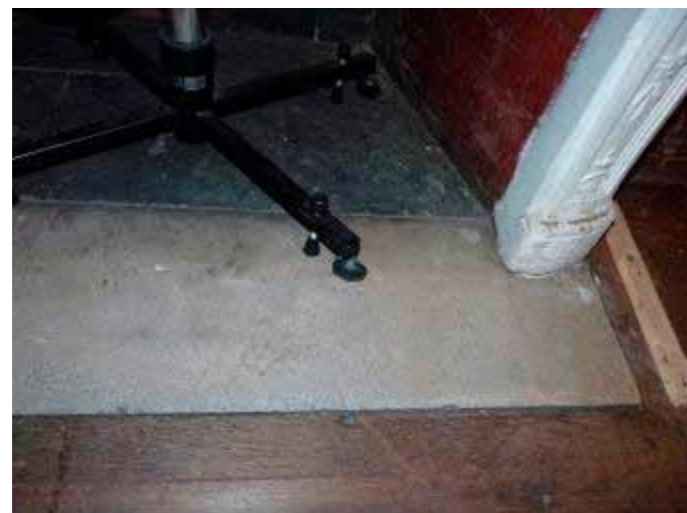
Figure 88 North West Bedroom, detail of fire hearth

- Remove any debris and surface dirt from the fireplace area and vacuum all exposed surfaces.
- Clean the hearth with V&A (50:50 white spirit:water with 1% Synperonic A7) mixture and rinse with white spirit.
- Carry out trials for effective remove modern emulsion, proprietary paint strippers may be acceptable. Spots or splashes of paint on the hearth can be removed mechanically with scalpels, taking great care not to scratch or mark the surface in any way.
- Apply protections to all areas of fireplace and parquet flooring prior to stripping, taking care not to affect other historical elements.
- Any replacement features should be matched to the original and be guided by references to historic photographs and literature.
- We recommend that the works are undertaken by specialist cleaners/conservators only and that further trials are carried out to establish best methods and materials.

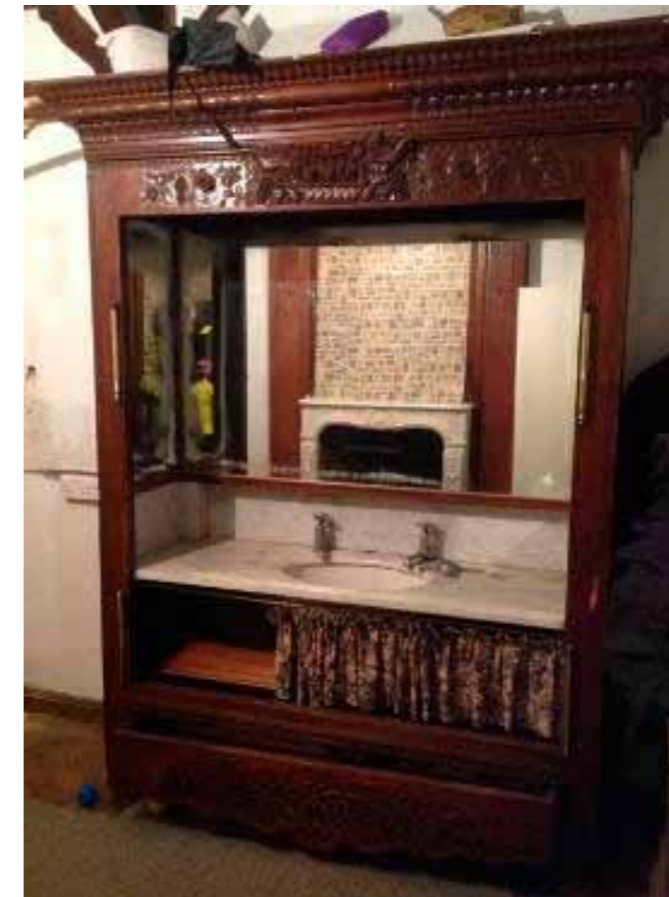
Figure 89 North West Bedroom, detail of wash area cupboard

- Remove surface dirt with brushes and vacuuming.
- Clean marble with V&A mix.
- Stubborn more ingrained dirt can be reduced significantly by using Prelim polishing cream gently applied over the soiled areas with cotton wool swabs and rinsed with white spirit.

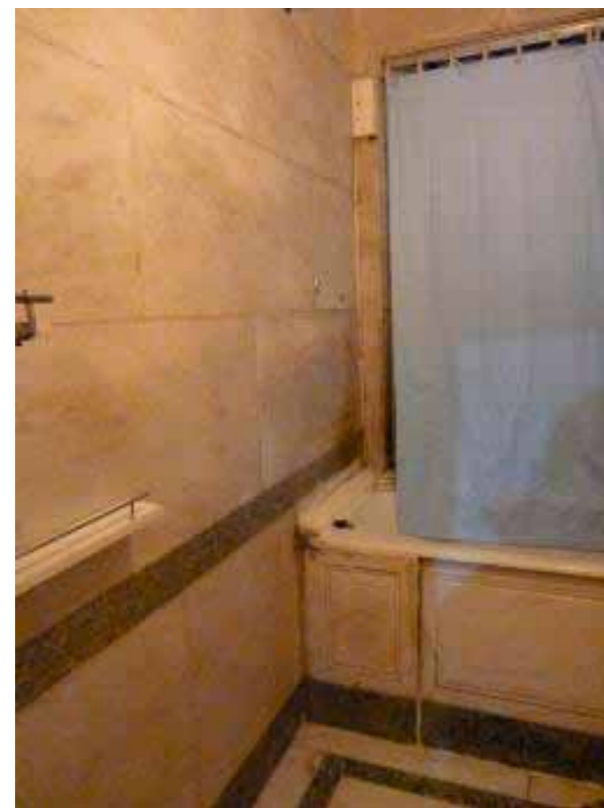
Although according to records the Bathroom is most probably a much later addition to the property it is very unusual in a house of this kind and represents a high level of craftsmanship despite its sorry state. The walls and floor are entirely lined with marble. Extensive cracking has occurred and much of the marble is stained and heavily soiled.

Figure 91 Bathroom, view west showing large marble wall tiles

- Remove dirt and reduce much of the staining with conservation-grade cleaning products such as V&A mix and Prelim polishing cream (as detailed before).
- We recommend carrying out further trials to establish the most suitable cleaning method for reducing staining and soiling without damaging the polished surfaces.
- Many interventions such as silicone sealants and adhesives will need to be removed. Carry out further trials to establish best methods and materials for cleaning other surfaces such as chrome and stainless steel fixings.

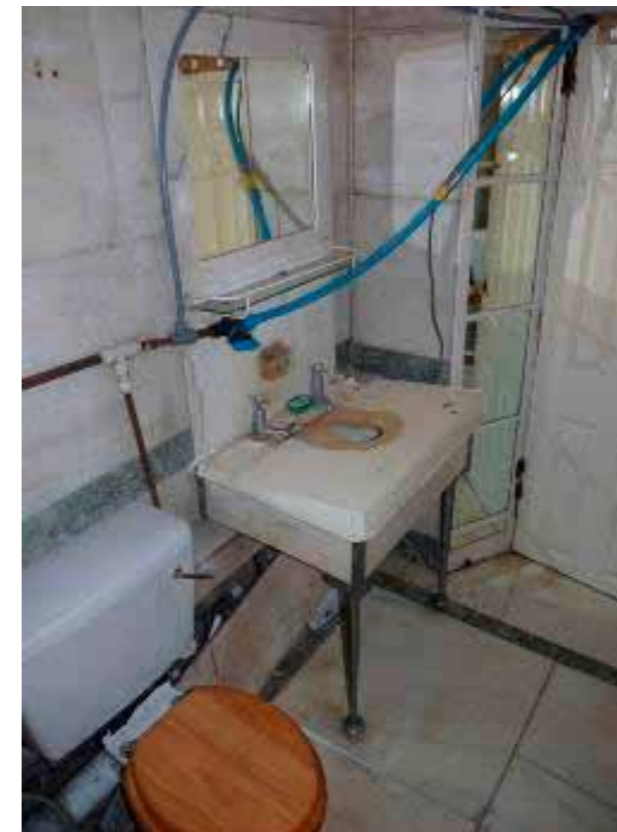
Figure 93 Bathroom, north elevation

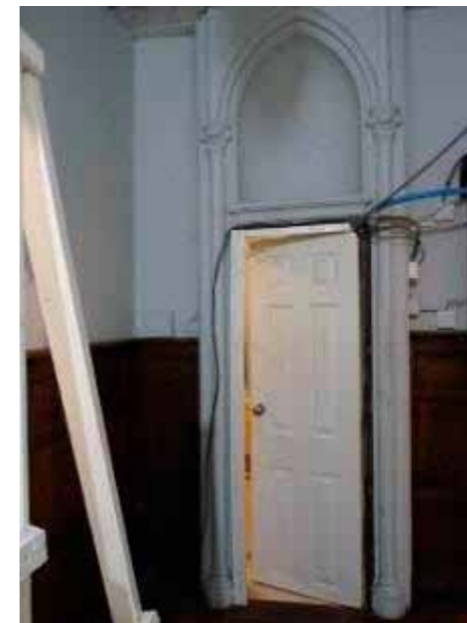
A modern door leading to the bathroom is set into a gothic style plaster archway on the west elevation. Continuing the gothic theme an intricately carved pulpit has been installed as a short set of stairs leading up to the entrance to South West Bedroom. A variety of timbers have been used in the construction of the pulpit, which detracts from its overall appearance.

Figure 96 Upper Landing, west elevation

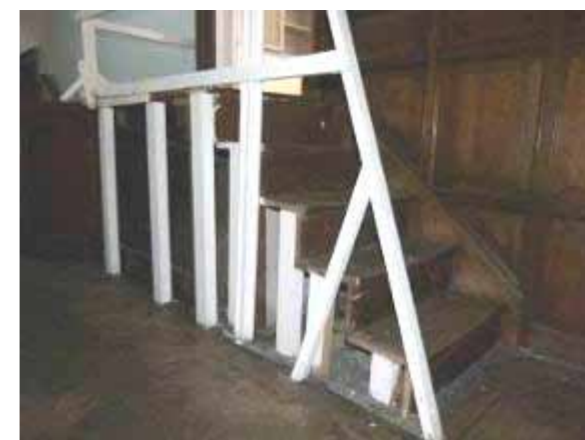
Figure 97 Pulpit Stairs viewed at floor level

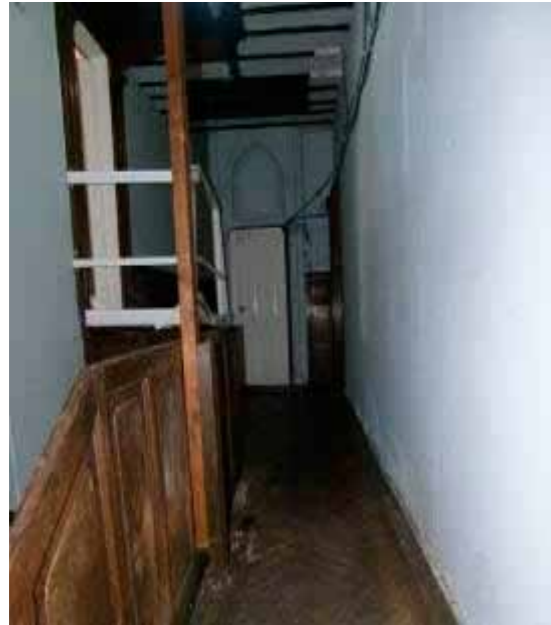
Figure 98 Upper Landing, view towards the pulpit and west elevation

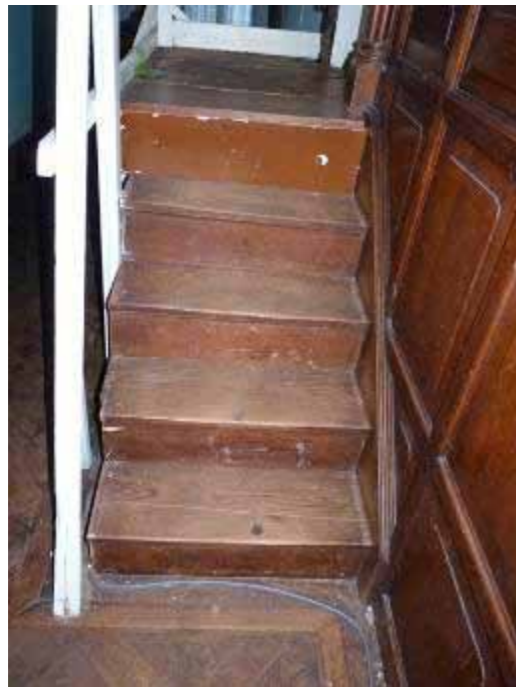
Figure 99 Pulpit stairs rising to South West Bedroom
