LISTED BUILDING CONSENT COMPLIANCE SUBMISSION

PRE-COMMENCEMENT CONDITION DISCHARGE APPLICATION

TRURO HOUSE

CONDITION ASSESSMENT AND
CONSERVATION RECOMMENDATIONS
FOR THE FIREPLACES AND
MAJOR DECORATIVE FEATURES

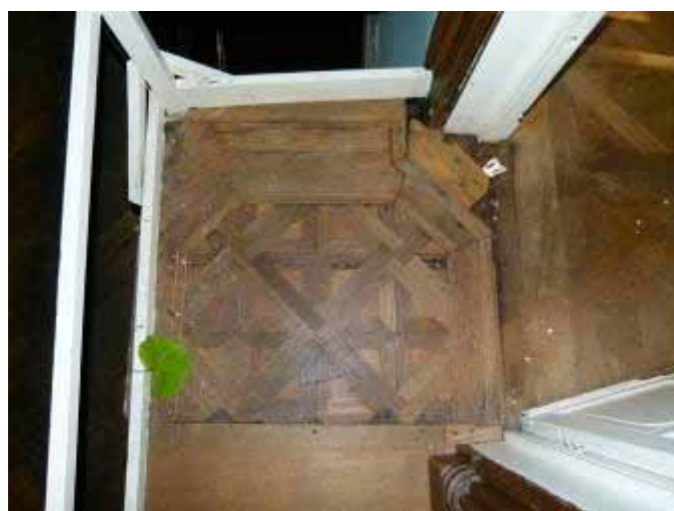
Figure 100 Pulpit, detail of parquet flooring

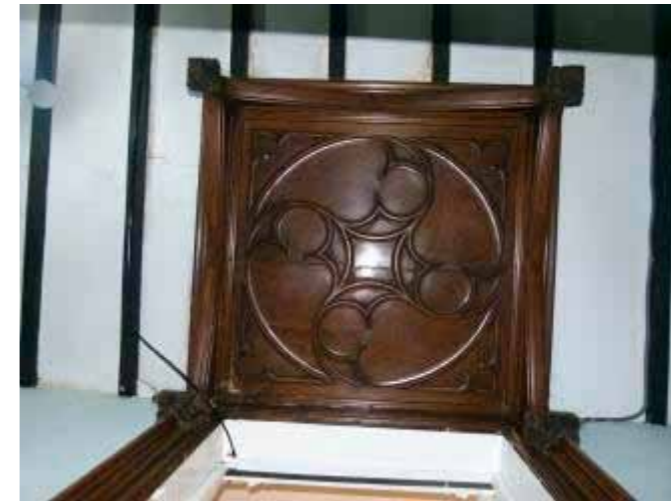
Figure 101 Pulpit, detail of ornately carved timber canopy

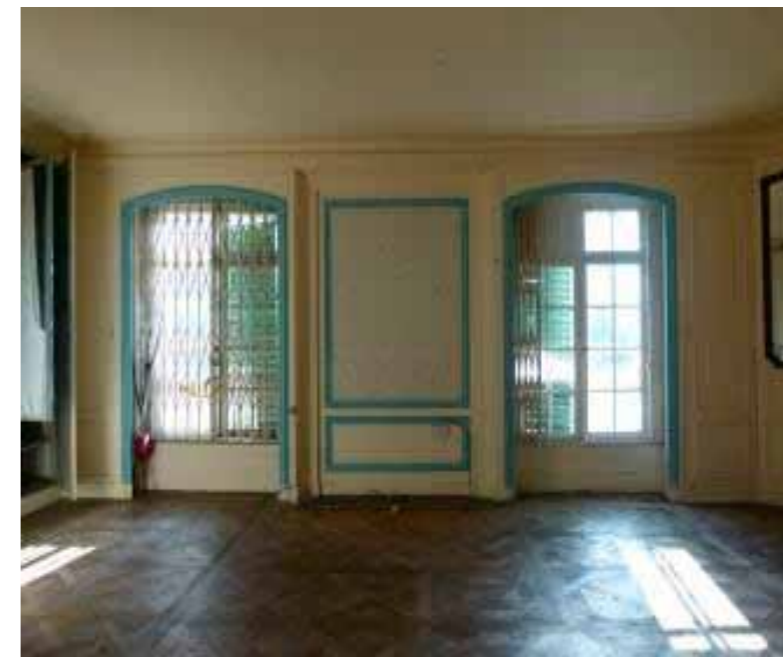
Figure 102 South West Bedroom, south elevation

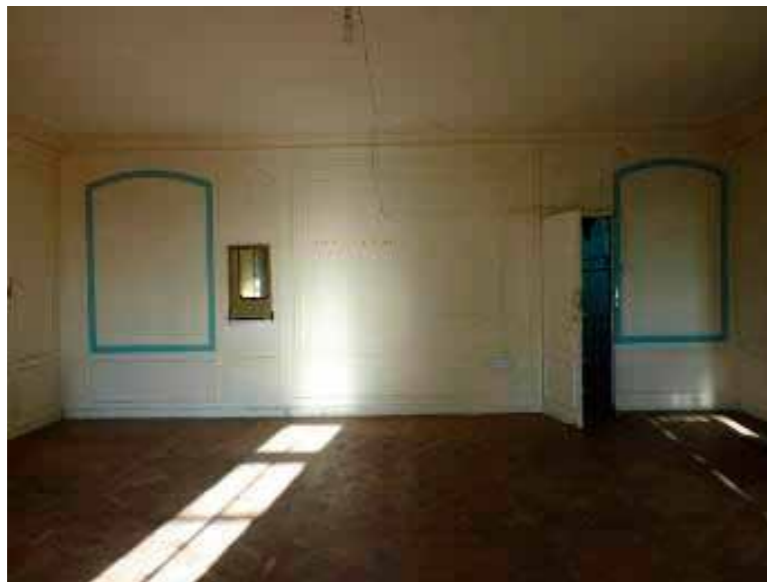
Figure 103 South West Bedroom, north elevation

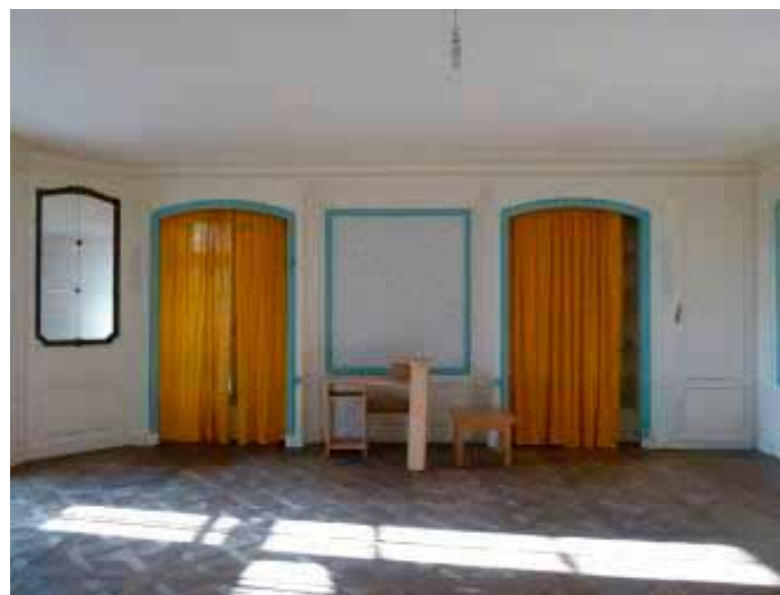
Figure 104 South West Bedroom, west elevation

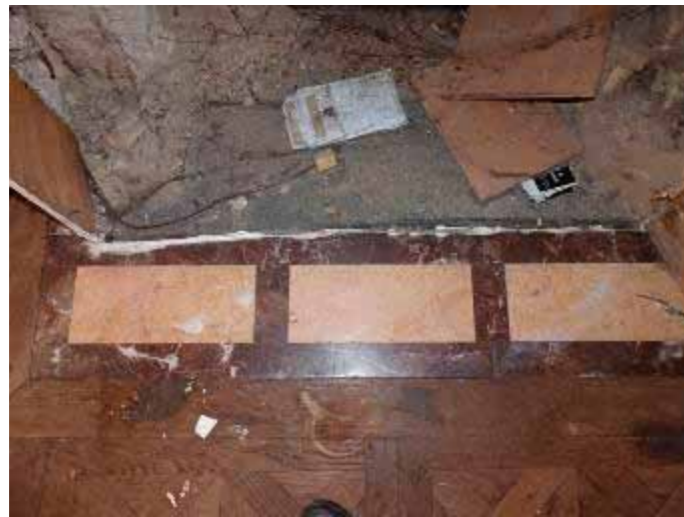
Figure 109 South West Bedroom, detail of original marble hearth
